**WETLAND DELINEATION REPORT
ANGEL RANCH 751 ACRES
POINTE COUPEE PARISH, LOUISIANA**

GEC Project Number: 0013.2122014.012

WETLAND DELINEATION REPORT ANGEL RANCH 751 ACRES POINTE COUPEE PARISH, NEW ROADS, LOUISIANA

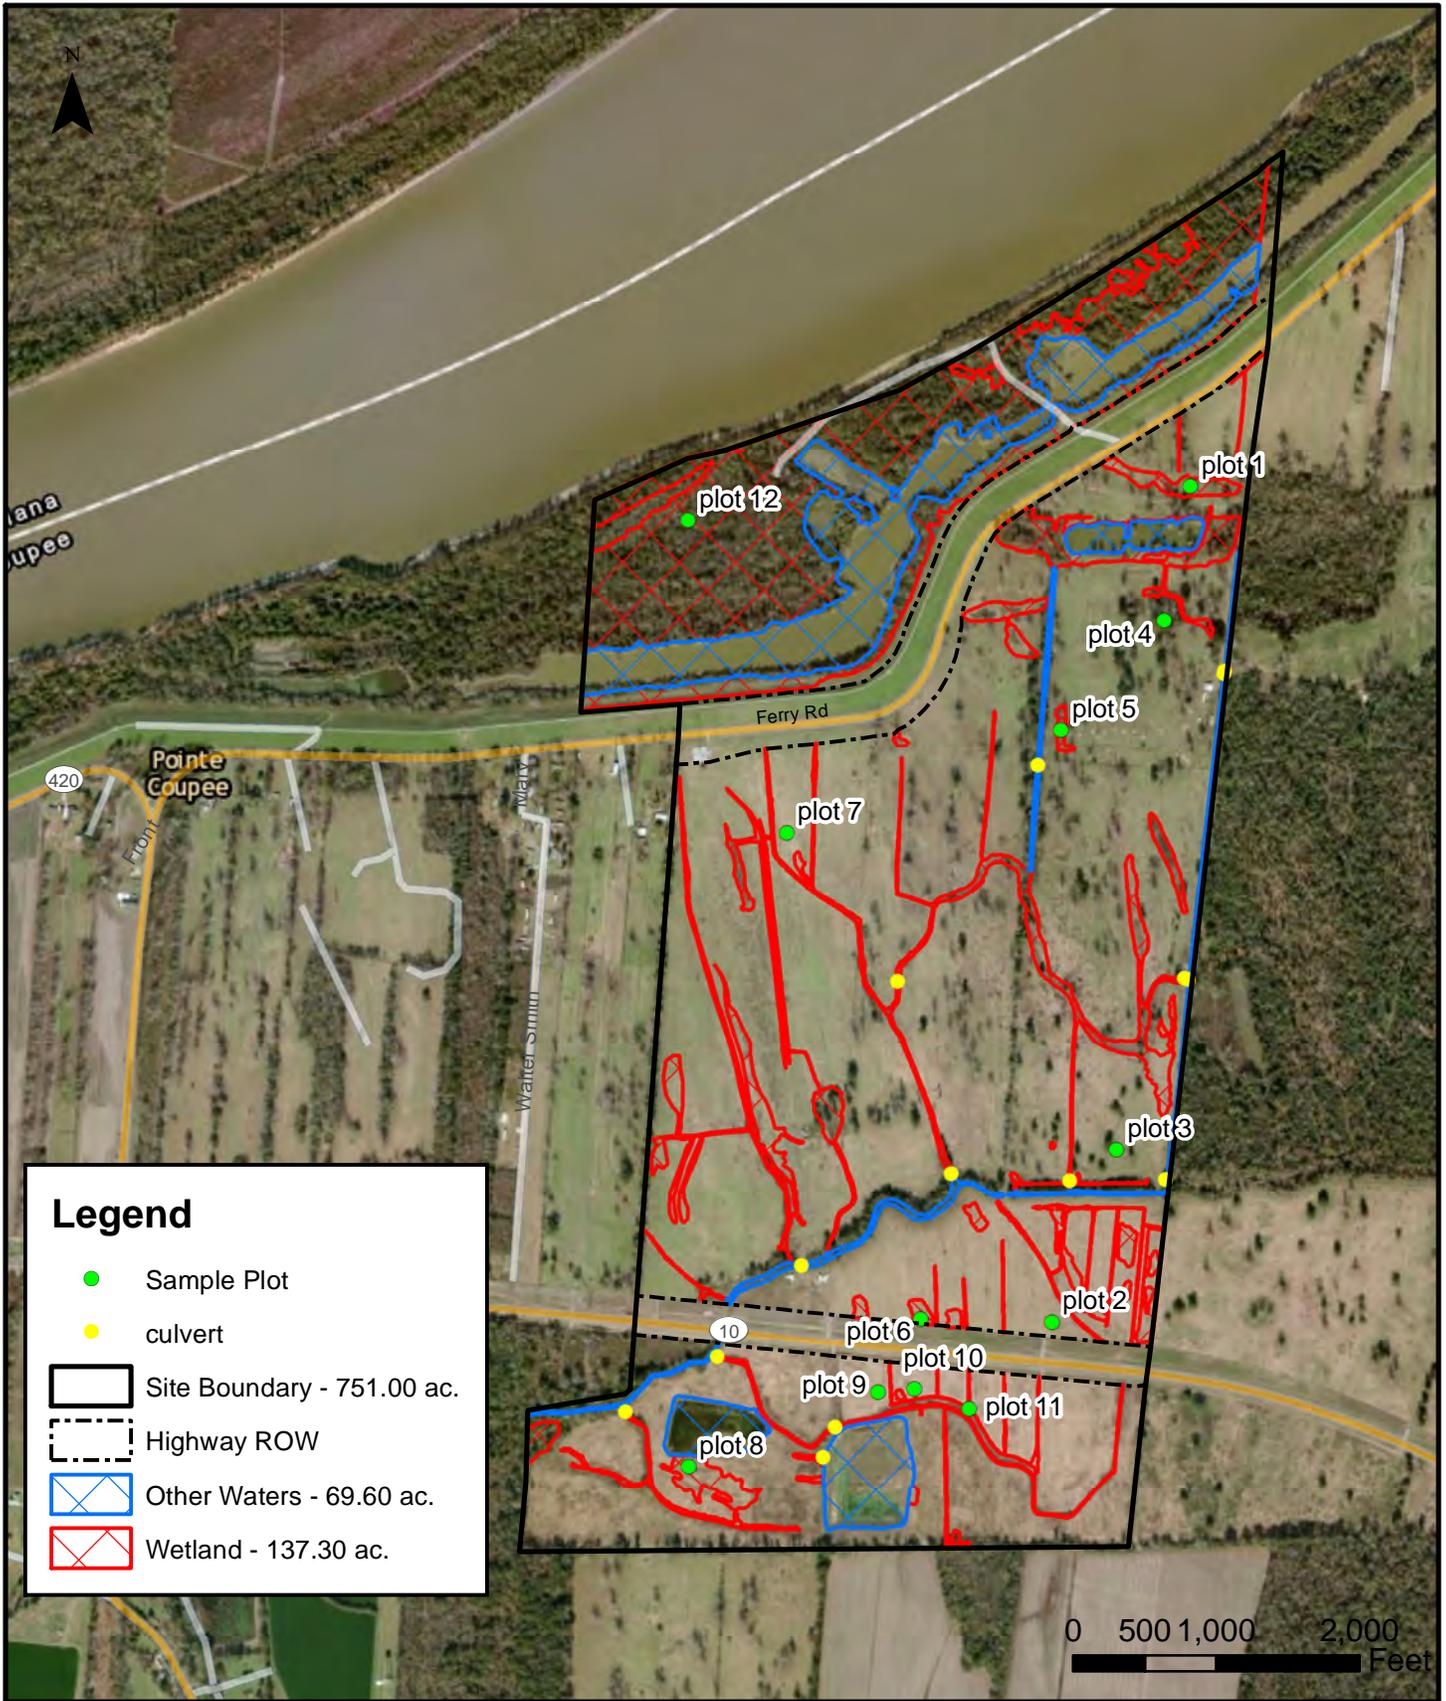
Figure: 3
Date: October 2014
Scale: 1:16,000
Source: ESRI/GEC
Map ID: 00132122014012-3151

- Sample Plot
- culvert
- Site Boundary - 751.00 ac.
- Highway ROW
- Other Waters - 69.60 ac.
- Wetland - 137.30 ac.

WETLAND MAP
 Wetland Delineation
 Angel Ranch - 751 Acres
 Baton Rouge Area Chamber
 Pointe Coupee Parish, Louisiana

Sample Plot - 1: Sample Plot 1 is located within a herbaceous depression situated in the northeast corner of the property just south of Ferry Road (Figure 3). Dominant vegetation within this habitat includes Savannah panic grass (*Phanopyrum gymnocarpon*), redtop panic grass (*Panicum rigidulum*), short-bristle beakrush (*Rhynchospora corniculata*), and creeping spotflower (*Spilanthes americana*). Non-dominant plants observed at the sample plot include Louisiana blackberry (*Rubus louisianus*), **lizard's tail** (*Saururus cernuus*), and northern spider-lily (*Hymenocallis occidentalis*). The hydrophytic vegetation criterion is met within this sample plot.

Sample Plot - 3: Sample Plot 3 is located along the east side of the property just north of LA Highway 10 within a pasture (Figure 3). The dominant herbaceous species recorded in this sample plot include marshpepper smartweed and annual sumpweed. Other non-dominant species occurring within the sample plot are Bermuda grass, creeping spotflower, Virginia button-weed, southern carpet grass, lance-leaf frog-fruit (*Phyla lanceolata*), chain-leaf aster (*Aster adnatus*), and Carolina nightshade. The hydrophytic vegetation criterion is met within this sample plot.

Sample Plot - 4: Sample Plot 4 is located along the east side of the property at the northern end within a stand of mature trees (Figure 3). The dominant trees within this sample plot include cherry-bark oak (*Quercus pagoda*), hickory pecan (*Carya illinoensis*), and American elm (*Ulmus americana*). Water oak (*Quercus nigra*) was also present but was not dominant. The herbaceous stratum was dominated by Bermuda grass and marshpepper smartweed. Occurrences of other non-dominant species present include arrow-leaf sida, Indian heliotrope (*Heliotropium indicum*), chamberbitter (*Phyllanthus urinaria*), and Carolina elephant-foot (*Elephantopus carolinianus*). The hydrophytic vegetation criterion is met within this sample plot.

Sample Plot - 5: Sample Plot 5 is located in the northeastern portion of the property within a herbaceous depression with a few trees around the perimeter (Figure 3). The dominant trees were pecan hickory and sugarberry (*Celtis laevigata*). The dominant herbaceous species recorded within this habitat is marshpepper smartweed. Other species recorded but less

Sample Plot - 6: Sample Plot 6 is located in the southern portion of the property just north of LA Highway 10 within pasture habitat (Figure 3). The dominant species within this herbaceous depression include annual sumpweed and marshpepper smartweed. Other less abundant species observed within this habitat include chain-leaf aster, lance-leaf frog-fruit, creeping spotflower, and green flatsedge. The hydrophytic vegetation criterion is met within this sample plot.

Sample Plot - 7: Sample Plot 7 is located within pasture habitat in the northwestern portion of the property just south of LA Highway 981 (Figure 3). This habitat was dominated by Bermuda grass, marshpepper smartweed, and annual sumpweed. Other less abundant species recorded within this sample plot include Pennsylvania smartweed (*Polygonum pennsylvanicum*), lance-leaf frog-fruit, creeping spotflower, Virginian button-weed, white clover (*Trifolium repens*), rough cockle-bur, and chain-leaf aster. The hydrophytic vegetation criterion is met within this sample plot.

Sample Plot - 8: Sample Plot 8 is located in the southwestern portion of the property within a herbaceous habitat adjacent to a pond (Figure 3). This herbaceous habitat is dominated by

Sample Plot - 12: Sample Plot 12 is located in the northwestern portion of the property on the river side of the protection levee within the forested batture (Figure 3). The dominant trees within this sample plot include pecan hickory and sugarberry. Other trees occurring but less abundant include common persimmon (*Diospyros virginiana*) and water-locust (*Gleditsia aquatica*). The shrub stratum was dominated by common buttonbush (*Cephalanthus occidentalis*) and swamp privet (*Forestiera acuminata*). Dominant herbaceous vegetation includes small-spike false-nettle (*Boehmeria cylindrical*), redvine (*Brunnichia cirrhosa*), and white heath aster (*Aster pilosus*). The dominant woody vine species include river-bank grape (*Vitis riparia*), trumpet creeper (*Campsis radicans*), and poison ivy (*Toxicodendron radicans*). Saw greenbrier (*Smilax bona-nox*) was also present but was not a dominant. The hydrophytic vegetation criterion is met within this sample plot.

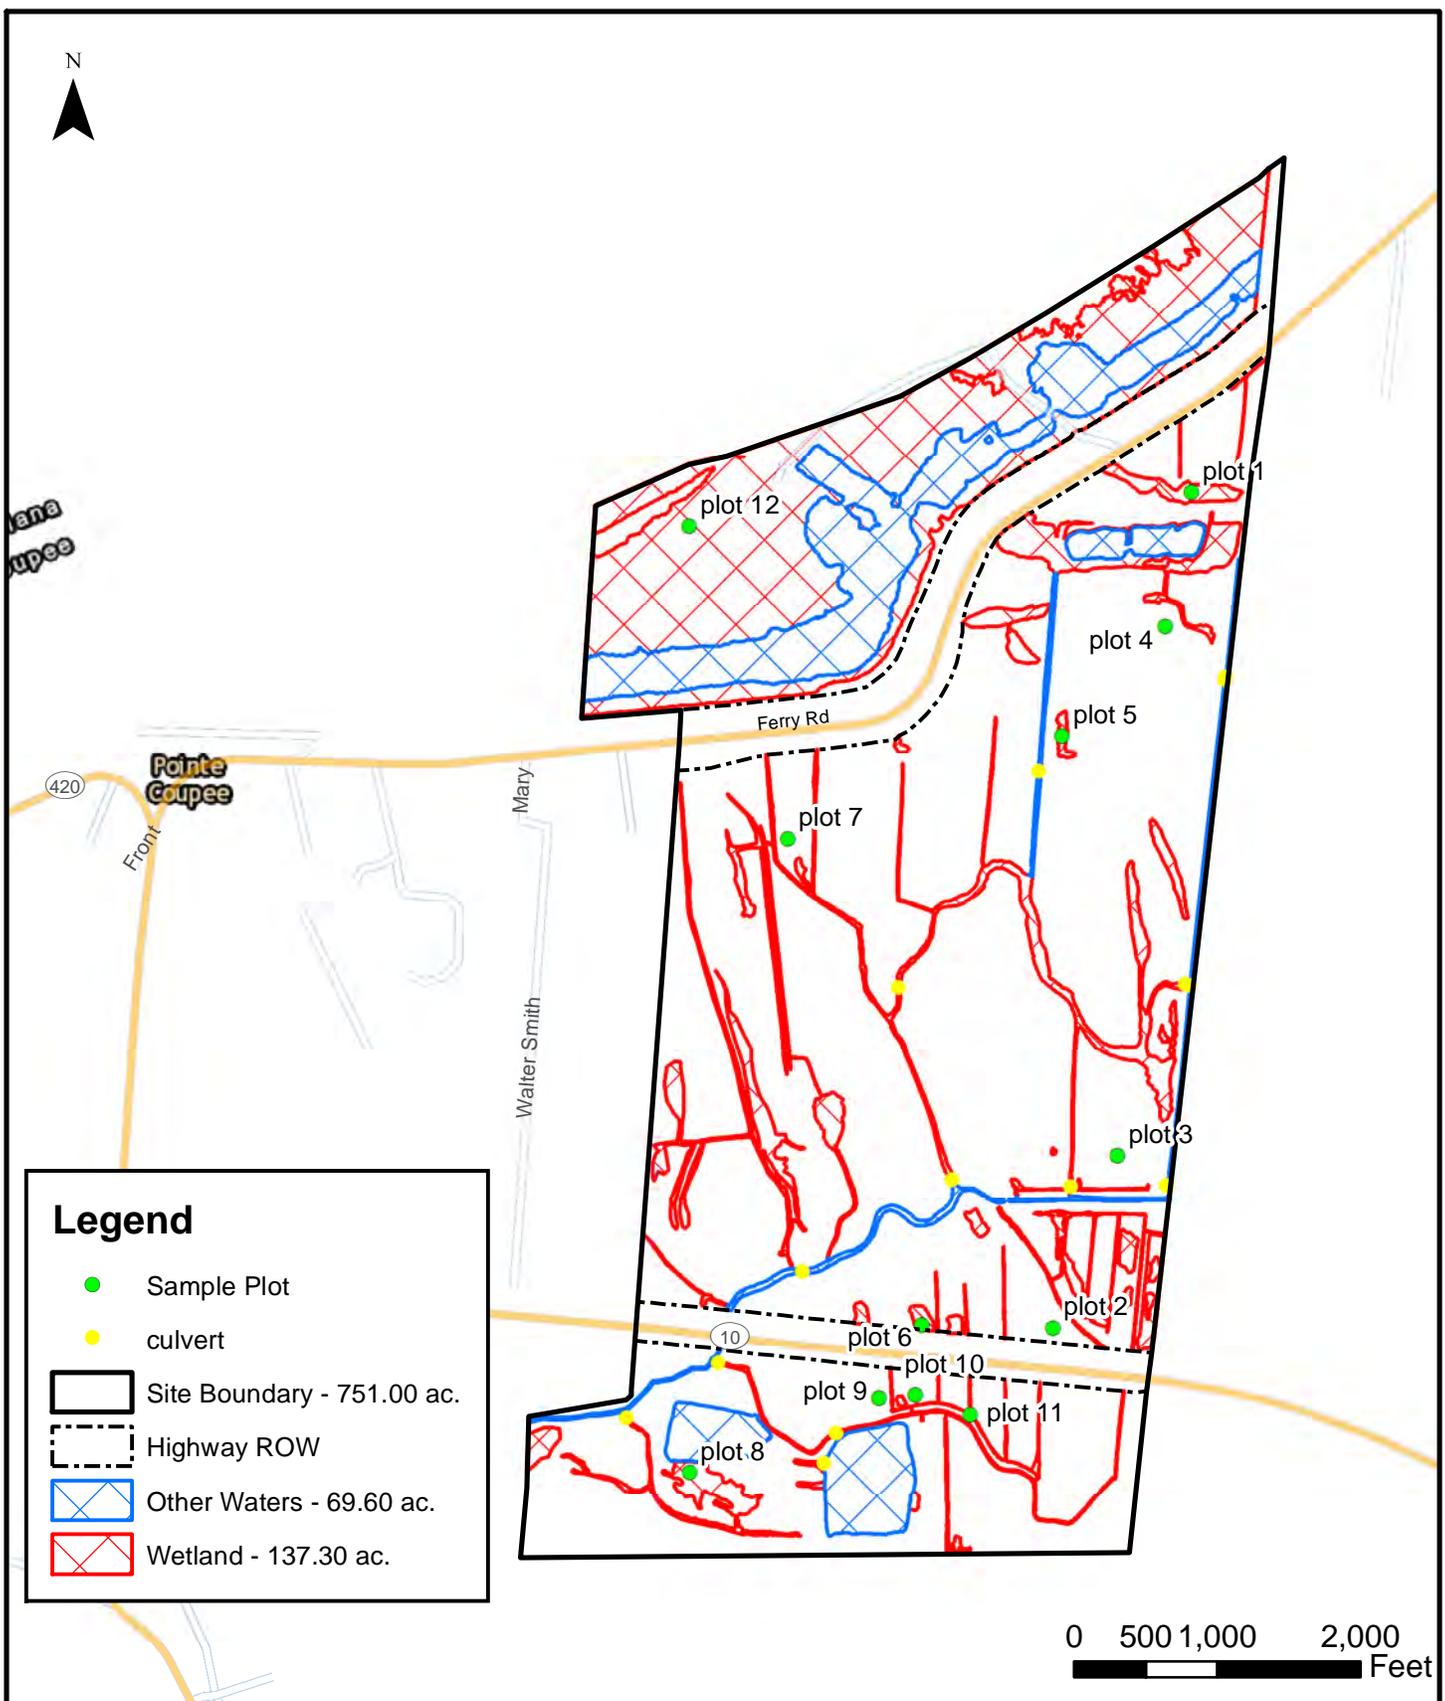
Figure: 4
Date: October 2014
Scale: 1:16,000
Source: ESRI/GEC
Map ID: 00132122014012-3151

- Sample Plot
- culvert
- Site Boundary - 751.00 ac.
- Highway ROW
- Other Waters - 69.60 ac.
- Wetland - 137.30 ac.

WETLAND MAP - JD
Wetland Delineation
Angel Ranch - 751 Acres
Baton Rouge Area Chamber
Pointe Coupee Parish, Louisiana

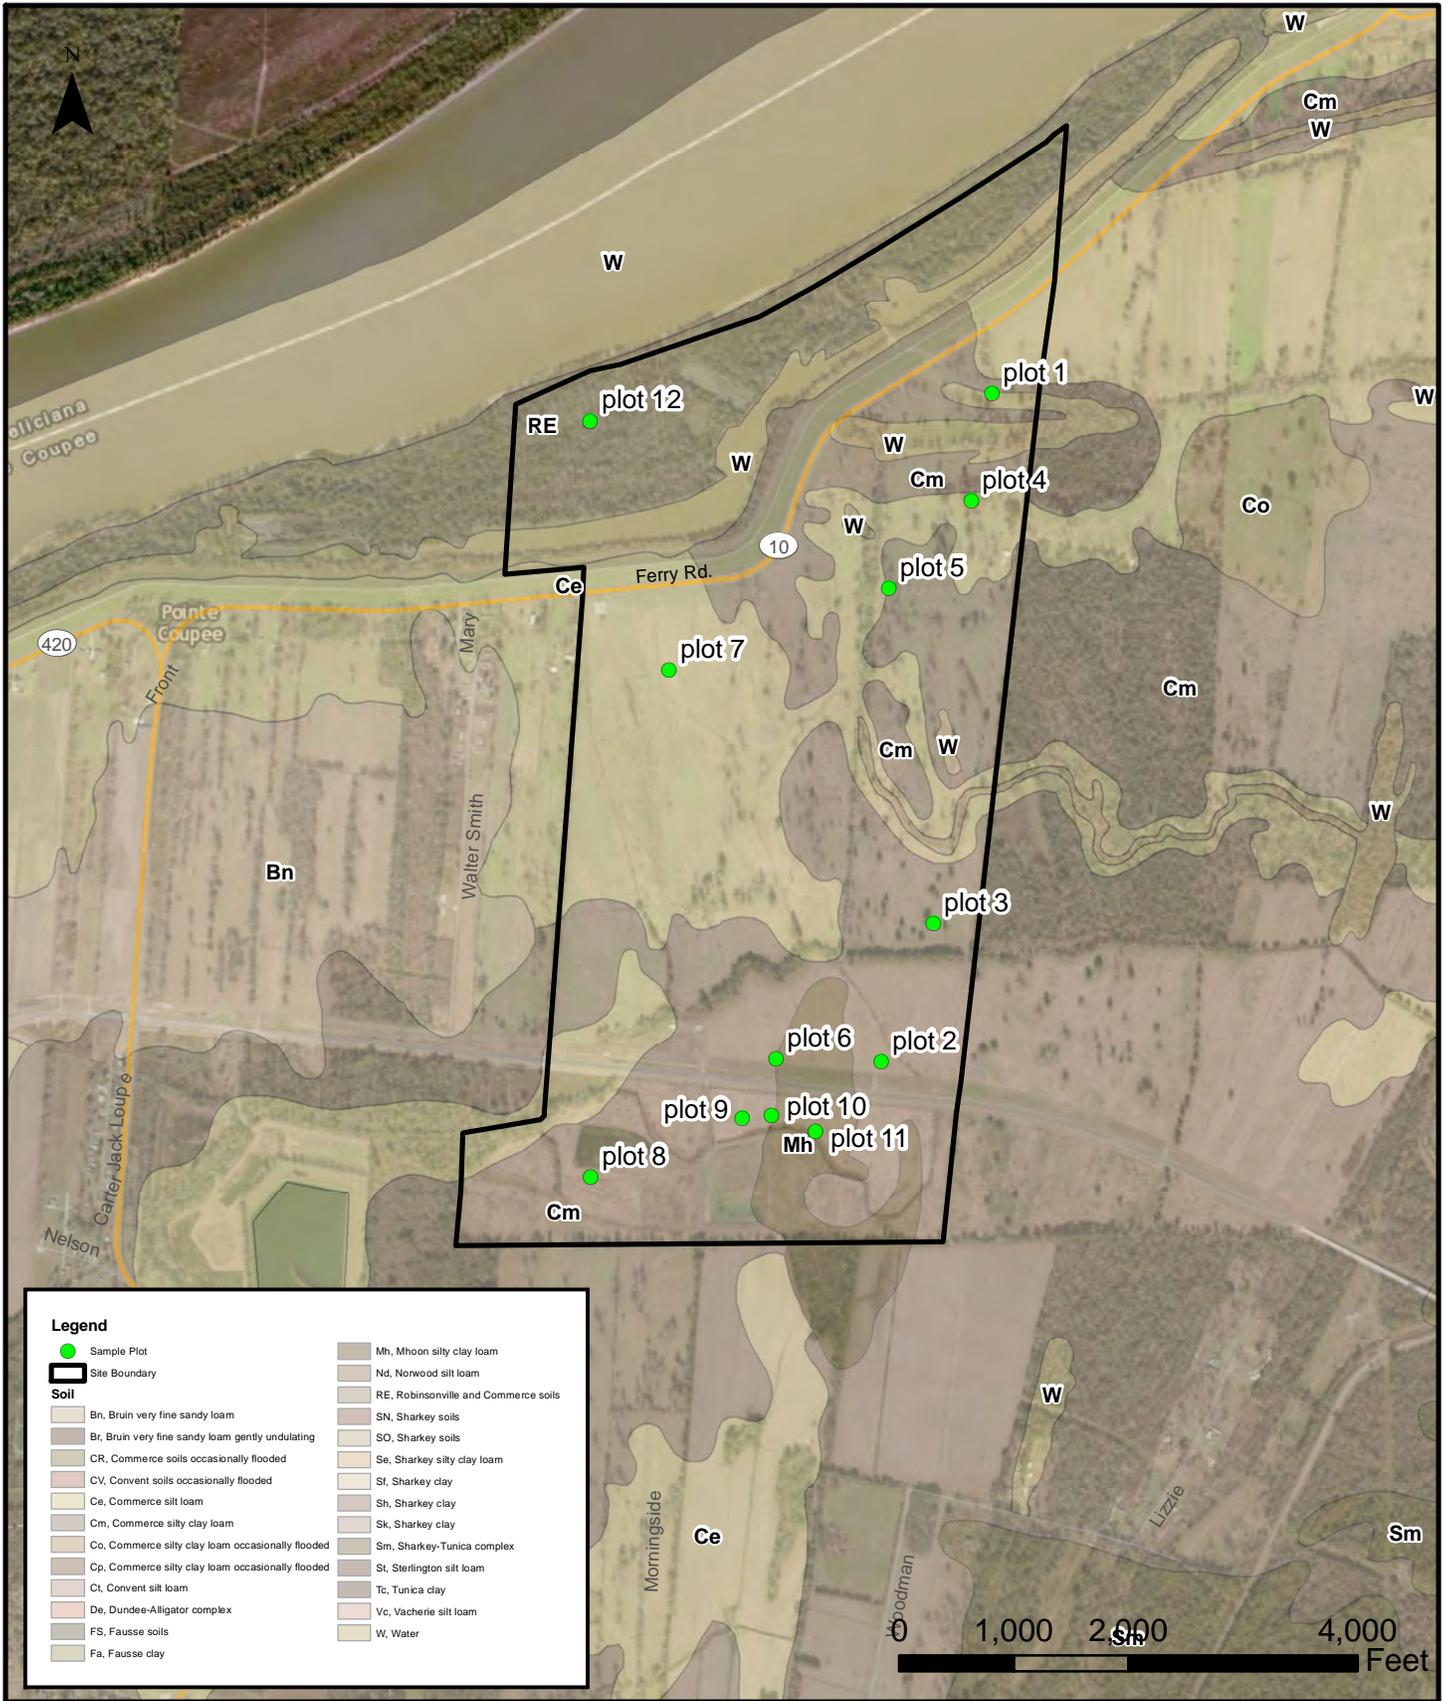
Figure: 5
 Date: October 2014
 Scale: 1:20,000
 Source: ESRI/GEC
 Map ID: 00132122014012-3151

SOILS MAP
 Wetland Delineation
 Angel Ranch - 751 Acres
 Baton Rouge Area Chamber
 Pointe Coupee Parish, Louisiana

A soil pit was excavated to a depth of approximately 18 inches at each sample plot. The pit remained open for at least 15 minutes to allow the pit to fill with water, if present. Soils were sampled along the exposed stratum. Information recorded on the data forms included soil colors (hue, value, and chroma as per the 1992 revised edition of the Munsell Color Chart), size, color, abundance, and depth of mottles, as well as soil texture. Soil texture was determined **using the "texture by feel" analysis**. Figure 5 depicts the soils mapped by the NRCS within the project area.

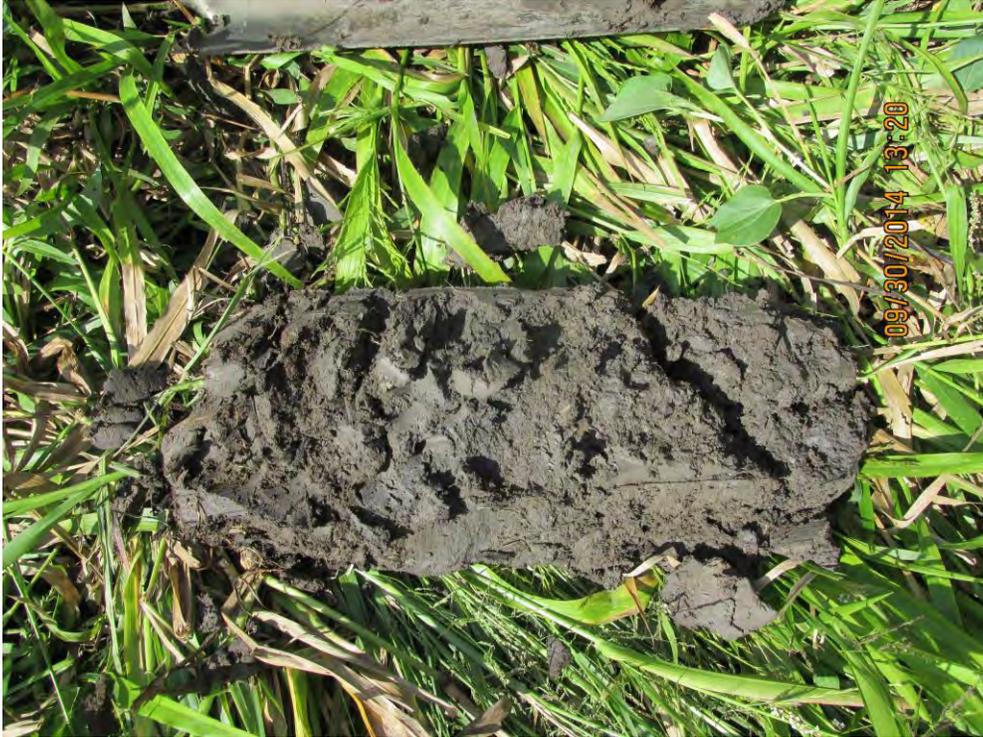
Photograph 1. Soil Profile Observed at Plot 1

The soils within this sample plot are mapped as Commerce silty clay loam. This series is listed on the National and the Louisiana Hydric Soils lists. Field investigations determined that the soils exhibit hydric soil indicators for a depleted matrix; therefore, the soils are considered hydric. Oxidized rhizospheres on living roots are the only primary indicator of wetland hydrology recorded at the site. However, secondary indicators include saturation visible on aerial imagery (C9), geomorphic position (D2), and a positive FAC-Neutral test (D5). The wetland hydrology criterion is met at this plot. It is GEC's opinion that this sample plot is within a wetland, based on the presence of all three wetland parameters (see Data Form Plot - 1).

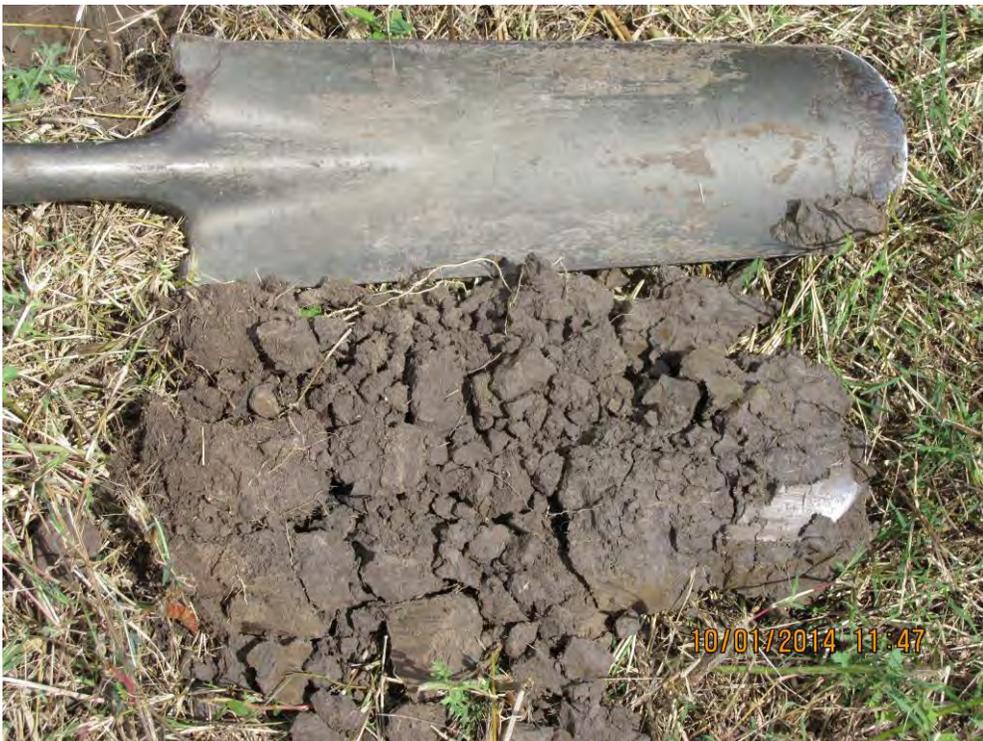
Photograph 2. Soil Profile Observed at Plot 2

The soils within this sample plot are mapped as Commerce silty clay loam. This series is listed on the National and the Louisiana Hydric Soils lists. Field investigations determined that the soils exhibited hydric soil indicators for a depleted matrix. Therefore, the hydric soils are present within this habitat. There are no primary or secondary indicators of hydrology recorded at this sample. It is GEC's opinion that this sample plot is not within a wetland, based on the absence of wetland hydrology (see Data Form Plot - 2).

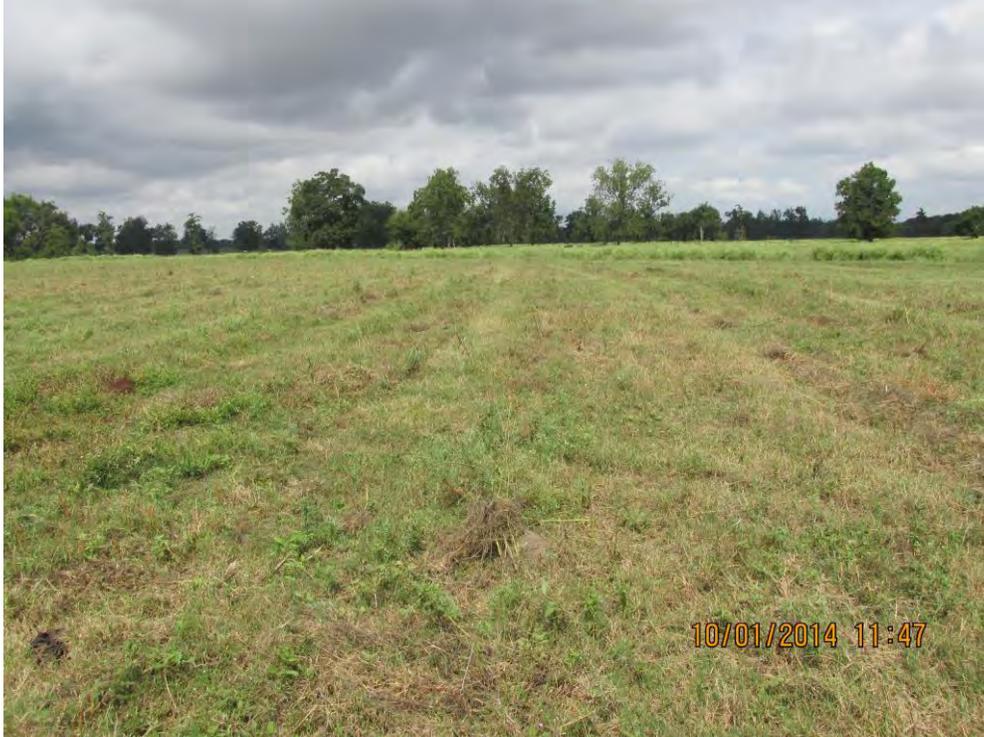
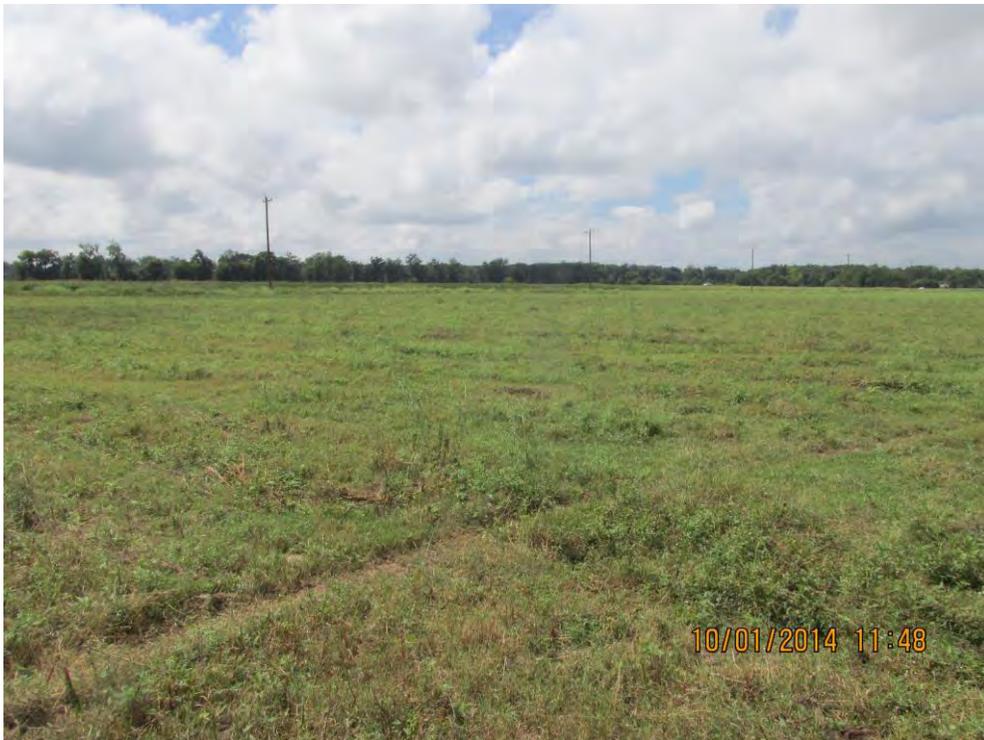
**Photograph 3. Overview of the Habitat Observed at Plot 2,
Facing North**

**Photograph 4. Overview of the Habitat Observed at Plot 2,
Facing Southwest**

Sample Plot - 2: Sample Plot 2 is located at the southern end of the property within pasture habitat just north of LA Highway 10 and along the eastern side of the property (Figure 3). This sample plot is dominated by Bermuda grass (*Cynodon dactylon*), southern carpet grass (*Axonopus affinis*), and Santa Maria feverfew (*Parthenium hysterophorus*). Other herbaceous species observed include marshpepper smartweed (*Polygonum hydropiper*), spiny amaranth (*Amaranthus spinosus*), annual sumpweed (*Iva annua*), arrow-leaf sida (*Sida rhombifolia*), Carolina nightshade (*Solanum carolinense*), Virginia button-weed (*Diodia virginiana*), and rough

cockle-bur (*Xanthium strumarium*). The hydrophytic vegetation criterion is met within this sample plot.

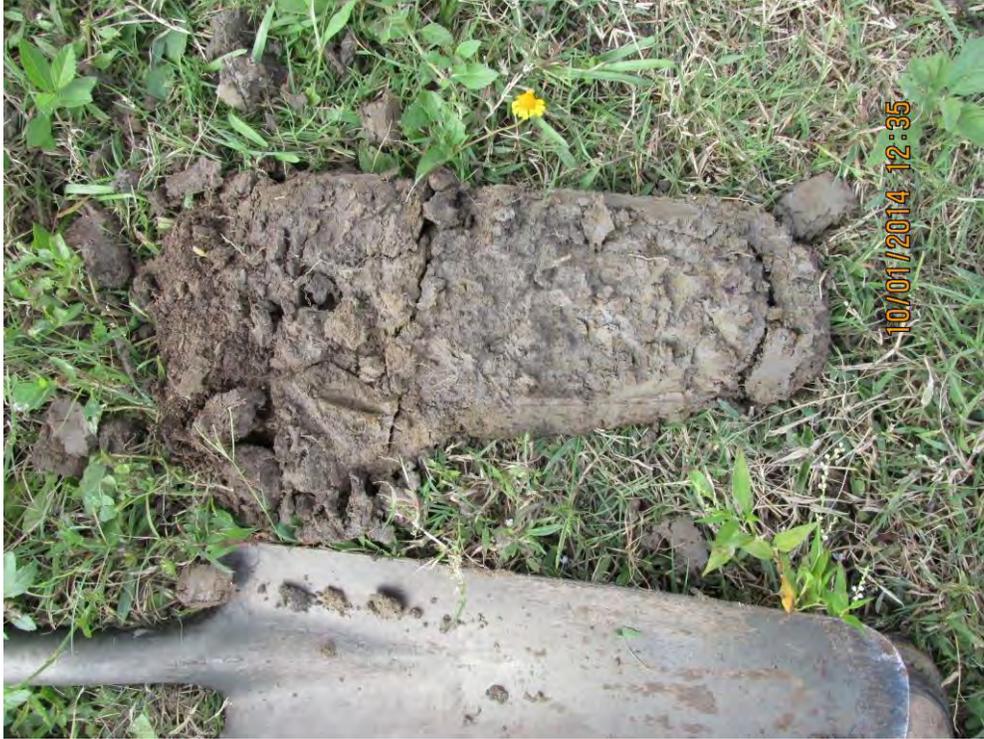
Photograph 5. Soil Profile Observed at Plot 3

The soils within this sample plot are mapped as Commerce silty clay loam. This series is listed on the National and the Louisiana Hydric Soils lists. Field investigations determined that the soils exhibited hydric soil indicators for a depleted matrix. Therefore, the hydric soils are present at this sample plot. The wetland hydrology criterion is not met at this plot due to the lack of any primary and only one secondary hydrology indicator, a positive FAC-Neutral test. It is GEC's opinion that this sample plot is not within a wetland, based on the lack of wetland hydrology within the plot (see Data Form Plot - 3).

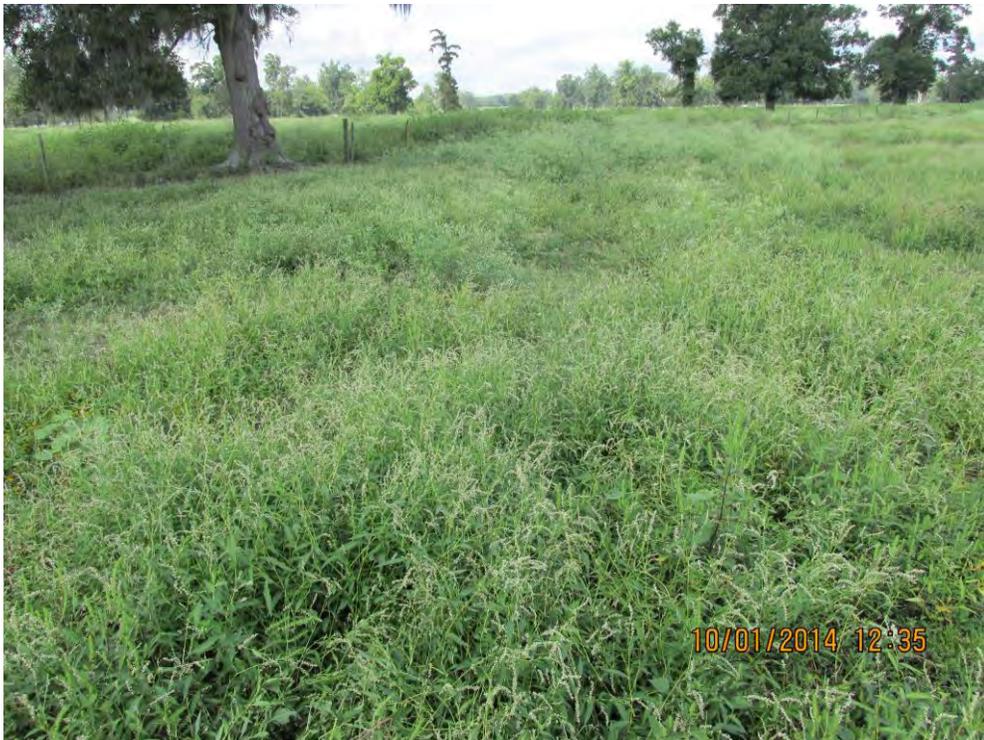
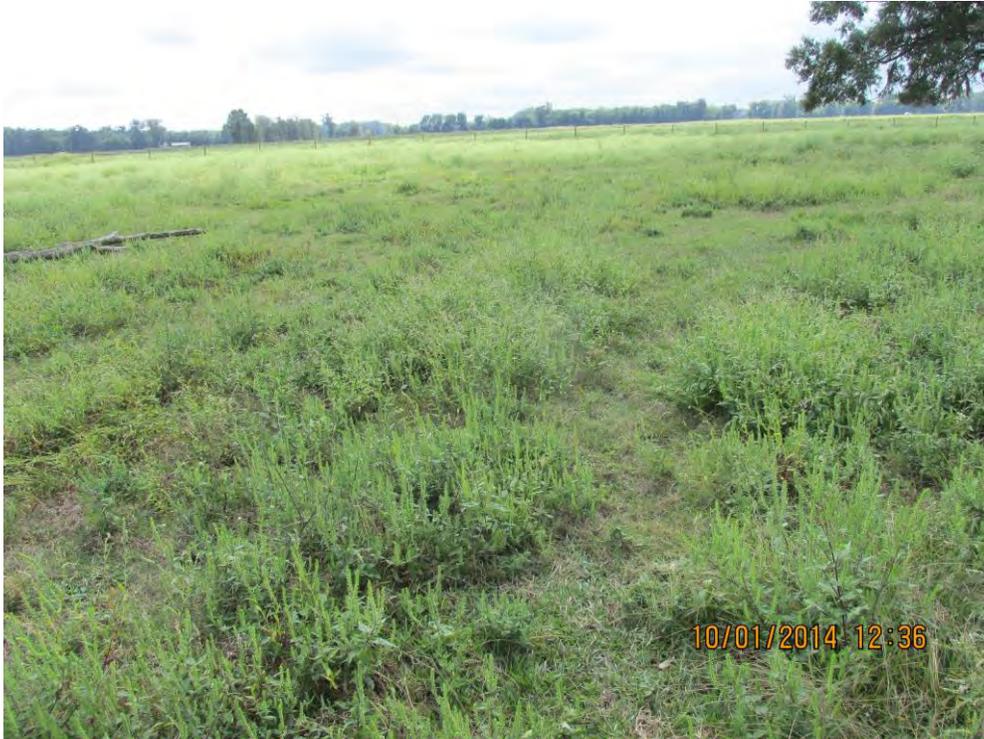
**Photograph 6. Overview of the Habitat Observed at Plot 3,
Facing Northwest**

**Photograph 7. Overview of the Habitat Observed at Plot 3,
Facing Southwest**

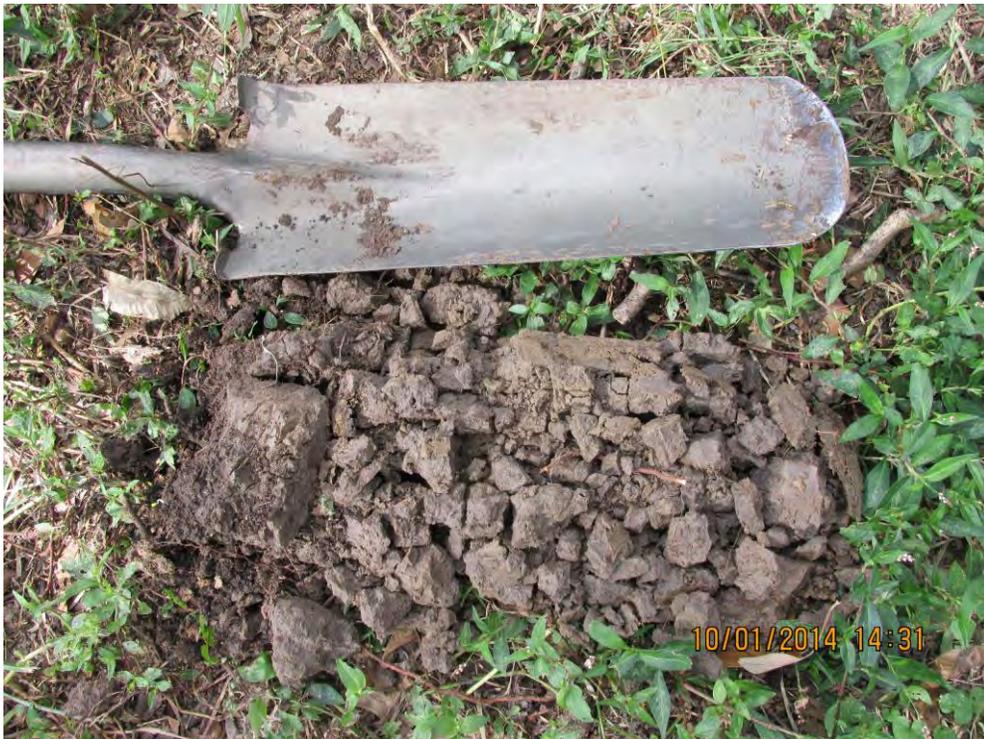
Photograph 8. Soil Profile Observed at Plot 4

The soils within this sample plot are mapped as Commerce silt loam. This series is listed on the National and the Louisiana Hydric Soils lists. Field investigations determined that the soils exhibited hydric soil indicators for a depleted matrix. Therefore, the hydric soils are present at this sample plot. The wetland hydrology criterion is not met at this plot due to the lack of any primary and only one secondary hydrology indicator, a positive FAC-Neutral test. It is GEC's opinion that this sample plot is not within a wetland, based on the lack of wetland hydrology indicators within the plot (see Data Form Plot - 4).

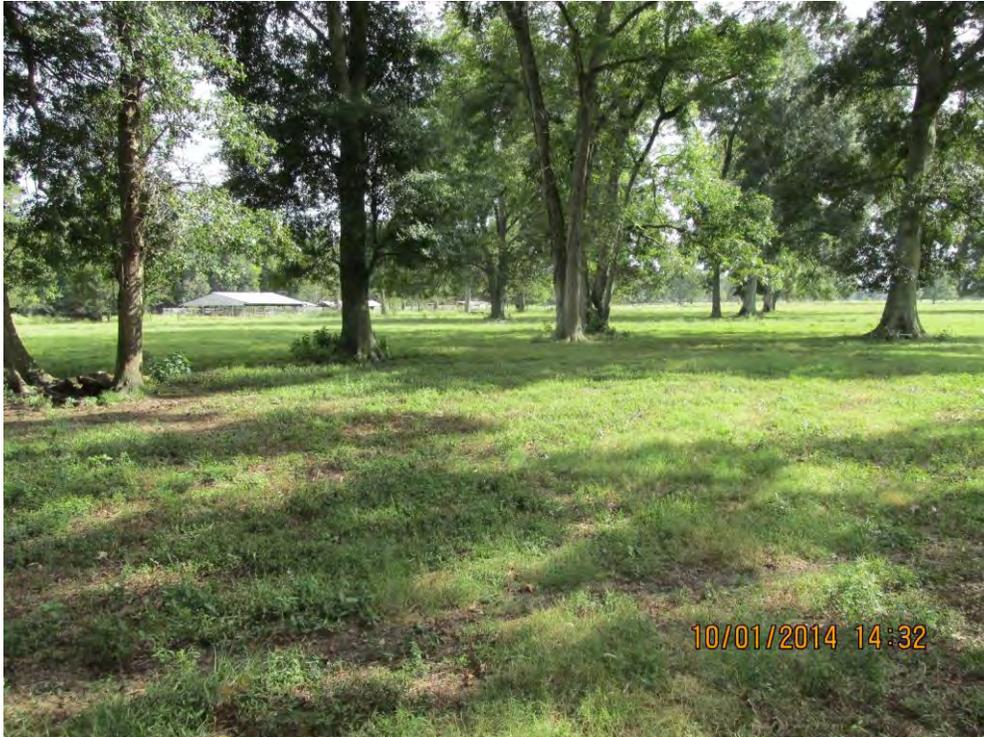
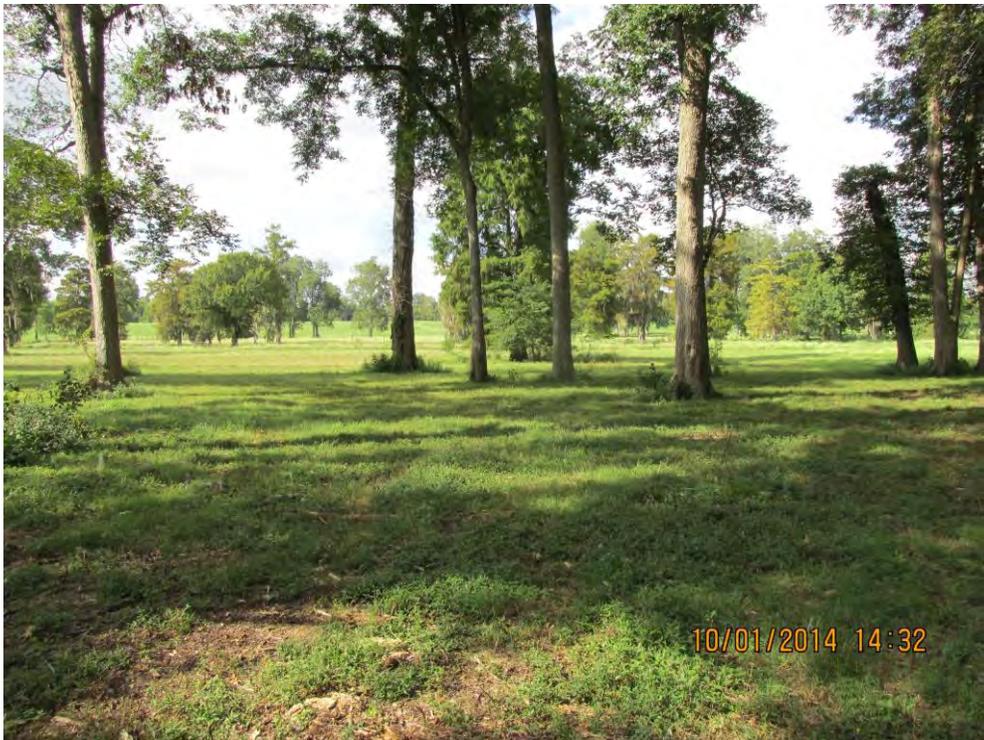
**Photograph 9. Overview of the Habitat Observed at Plot 4,
Facing South**

**Photograph 10. Overview of the Habitat Observed at Plot 4,
Facing North**

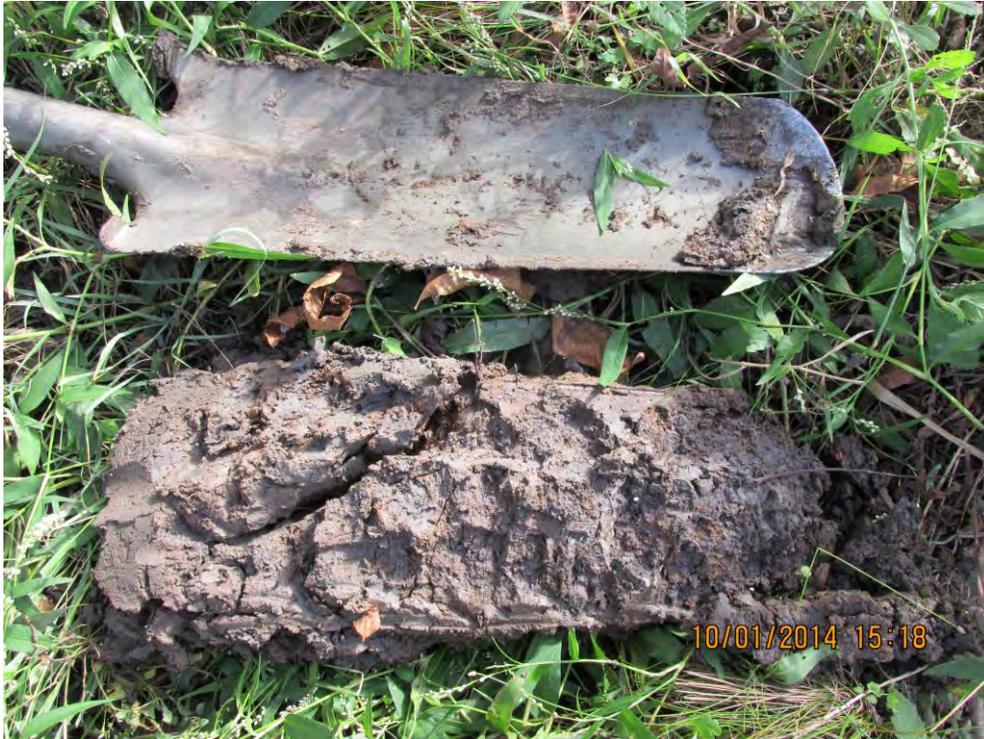
Photograph 11. Soil Profile Observed at Plot 5

The soils within this sample plot are mapped as Commerce silty clay loam. These series are both listed on the National and the Louisiana Hydric Soils lists. Field observations concluded that the hydric soils criterion is met within this plot based on the presence of hydric soil indicators for a depleted matrix. Primary wetland hydrology indicators include saturation (A3), water-stained leaves (B9), and oxidized rhizospheres on living roots (C3). Secondary wetland hydrology indicators observed and recorded at the sample plot are crayfish burrows (C8) and a positive FAC-Neutral test (D9). The wetland hydrology criterion is met at this plot. It is GEC's opinion that this sample plot is within a wetland, based on the presence of hydrophytic vegetation, hydric soils and wetland hydrology within the plot (see Data Form Plot - 5).

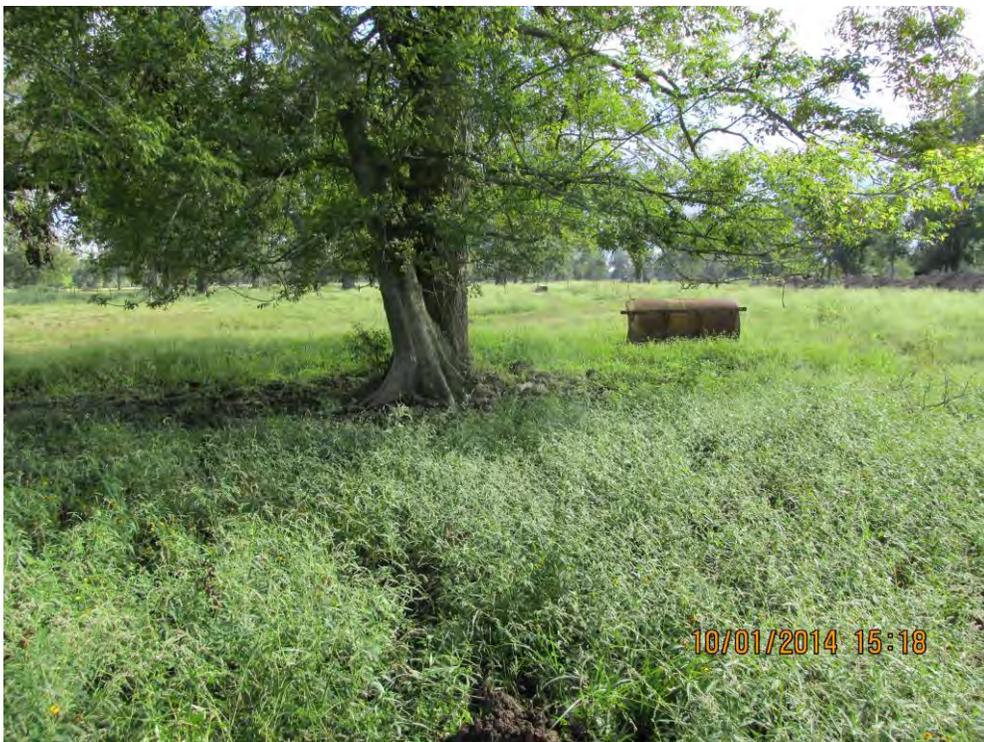
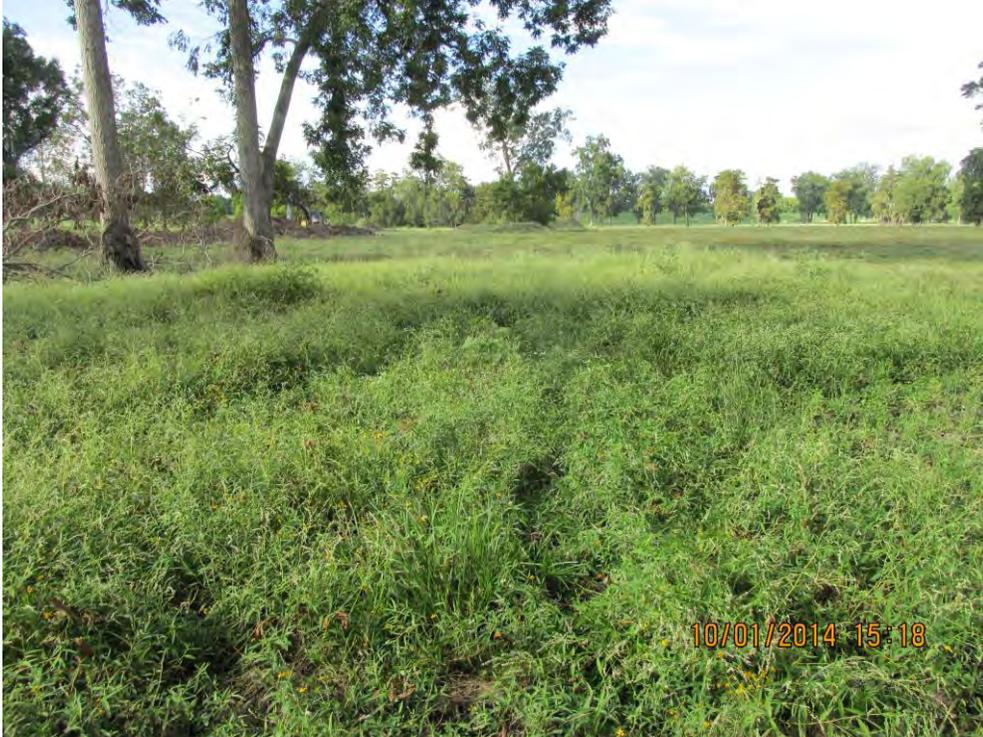
**Photograph 12. Overview of the Habitat Observed at Plot 5,
Facing South**

**Photograph 13. Overview of the Habitat Observed at Plot 5,
Facing North**

abundant are creeping spotflower, blunt spikerush (*Eleocharis obtuse*), annual sumpweed, blunt broom sedge (*Carex tribuloides*), green flatsedge (*Cyperus virens*), and soft rush (*Juncus effusus*). The hydrophytic vegetation criterion is met within this sample plot.

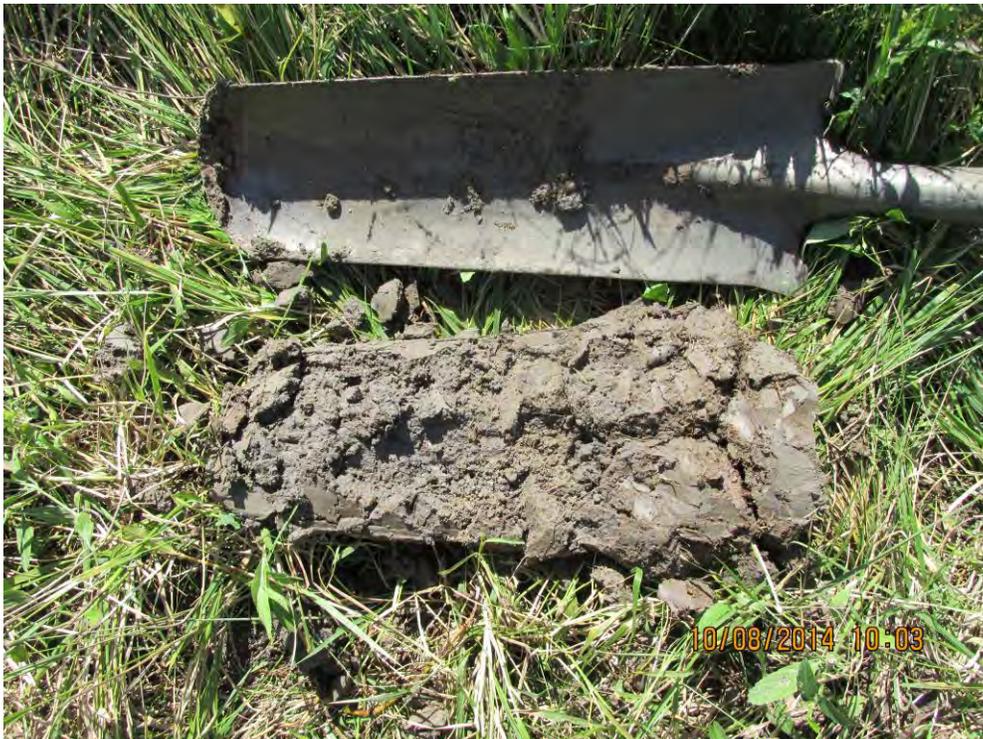
Photograph 14. Soil Profile Observed at Plot 6

The soil series mapped at this plot is the Mhoon silty clay loam. This series is listed on the National and the Louisiana Hydric Soils lists. Field observations concluded that the hydric soils criterion is met within this plot based on the presence of hydric soil indicators for a depleted matrix. Oxidized rhizospheres is the only primary wetland hydrology indicator recorded at the sample plot. Secondary indicators include crayfish burrows (C8) and a positive FAC-Neutral test. The wetland hydrology criterion is met at this plot. It is GEC's opinion that this sample plot is within a wetland, based on the presence of hydrophytic vegetation, hydric soils and wetland hydrology within the plot (see Data Form Plot - 6).

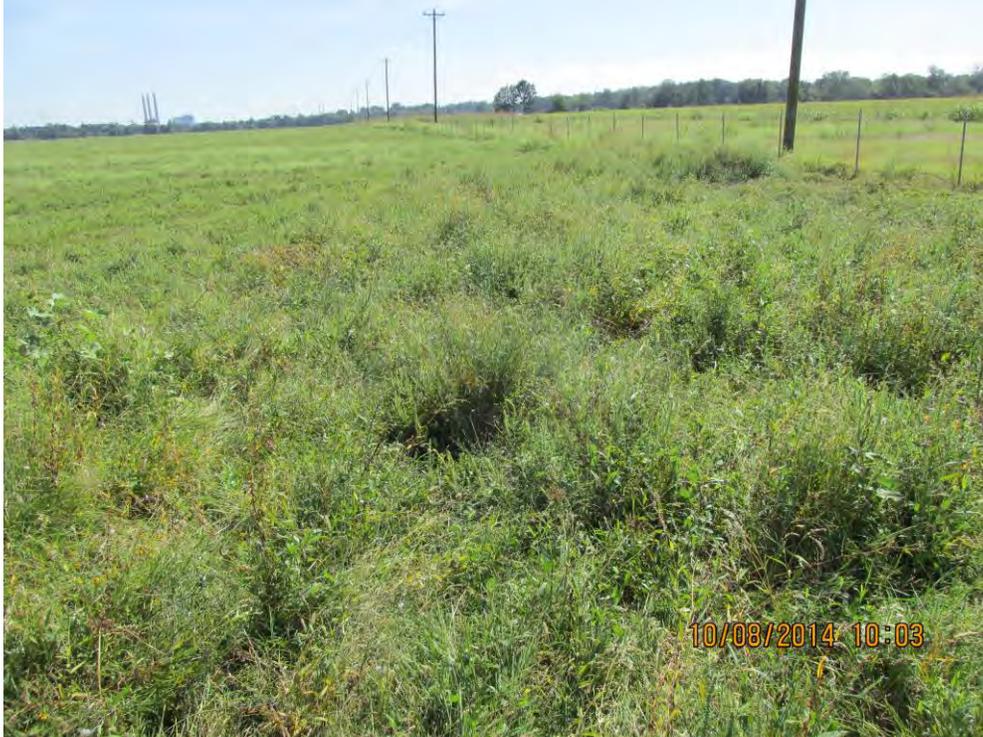
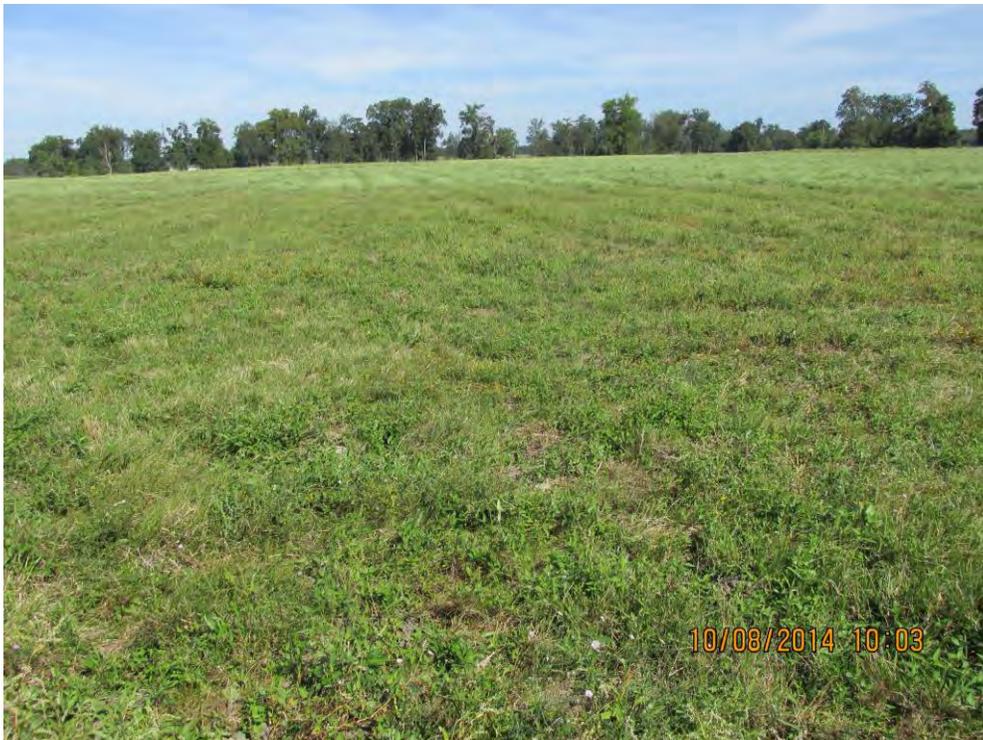
**Photograph 15. Overview of the Habitat Observed at Plot 6,
Facing East**

**Photograph 16. Overview of the Habitat Observed at Plot 6,
Facing North**
