**WETLAND DELINEATION REPORT
ANGEL RANCH 751 ACRES
POINTE COUPEE PARISH, LOUISIANA**

GEC Project Number: 0013.2122014.012

WETLAND DELINEATION REPORT ANGEL RANCH 751 ACRES POINTE COUPEE PARISH, NEW ROADS, LOUISIANA

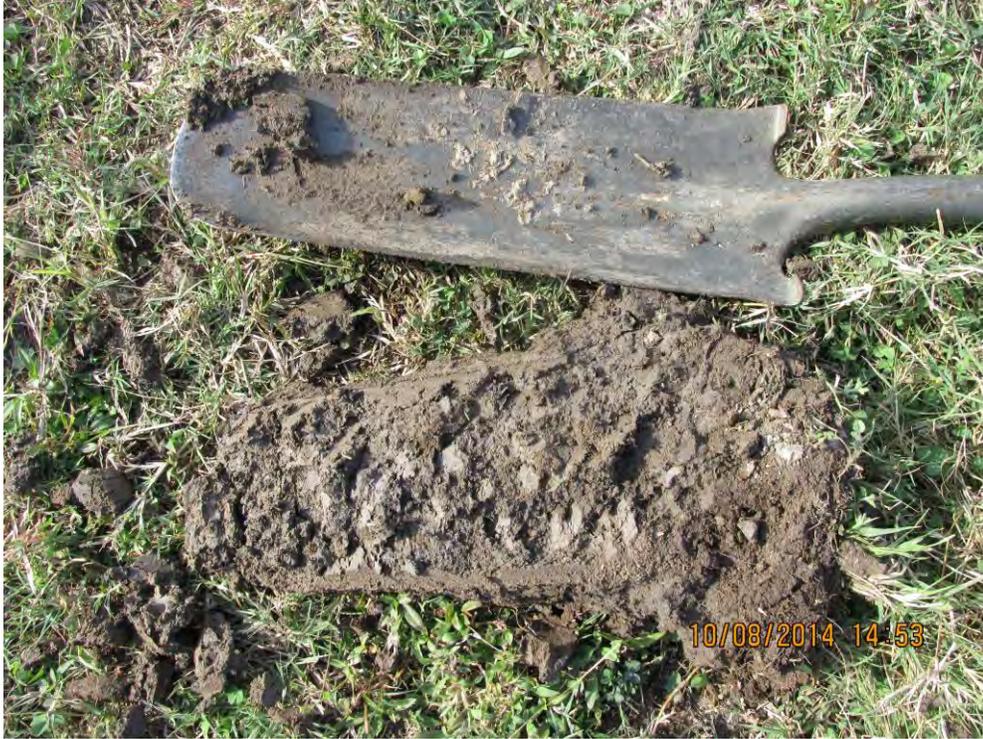
Photograph 17. Soil Profile Observed at Plot 7

The soil series mapped at this plot is the Commerce silt loam. This series is listed on the National and the Louisiana Hydric Soils lists. Field observations concluded that the hydric soils criterion is met within this plot based on the presence of hydric soil indicators for a depleted matrix. There were no primary wetland hydrology indicators observed at this plot and the only secondary indicator recorded was a positive FAC-Neutral test. The wetland hydrology criterion is not met at this plot. It is GEC's opinion that this sample plot is not within a wetland, based on the lack of wetland hydrology within the plot (see Data Form Plot - 7).

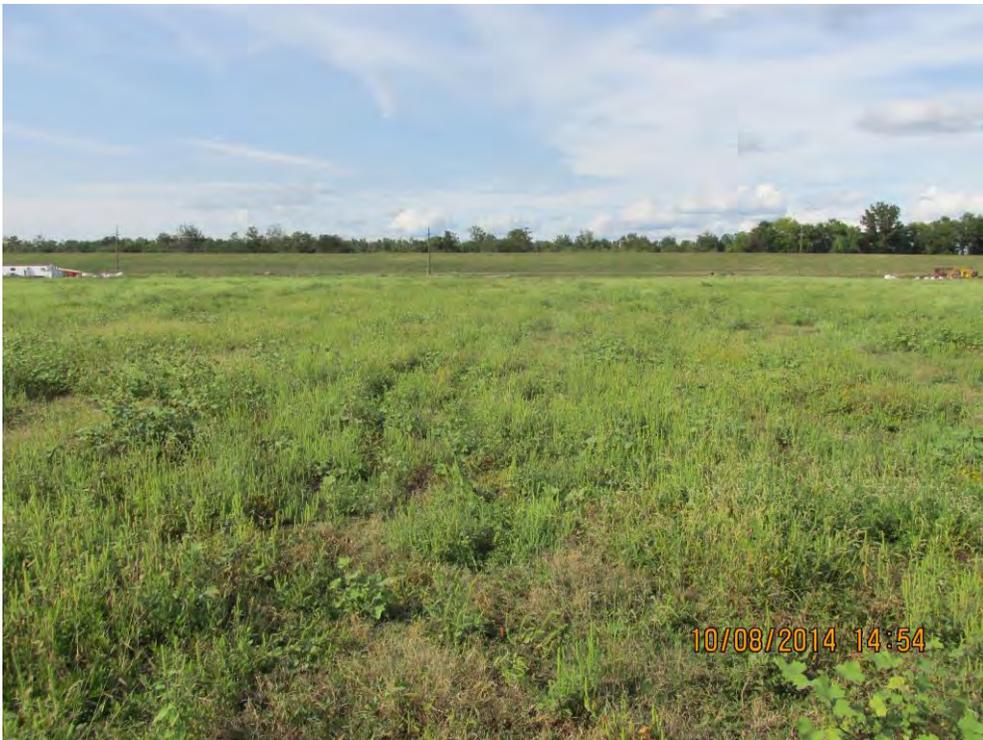
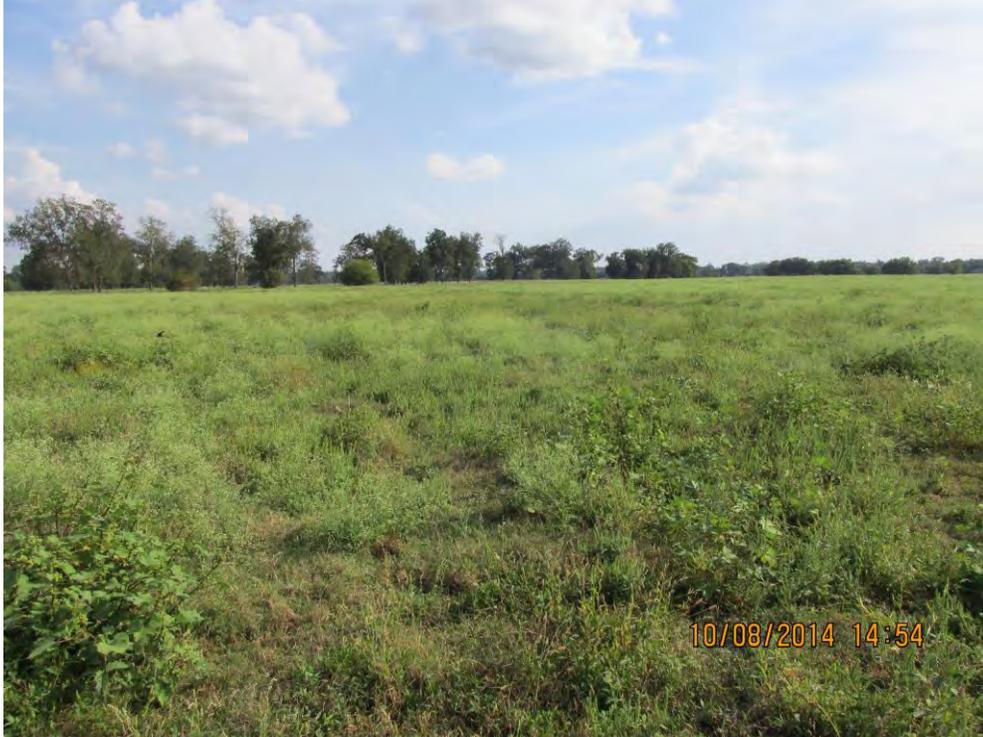
Photograph 18. Overview of the Habitat Observed at Plot 7, Facing North

**Photograph 19. Overview of the Habitat Observed at Plot 7,
Facing East**

Sample Plot - 7: Sample Plot 7 is located within pasture habitat in the northwestern portion of the property just south of LA Highway 981 (Figure 3). This habitat was dominated by Bermuda grass, marshpepper smartweed, and annual sumpweed. Other less abundant species recorded within this sample plot include Pennsylvania smartweed (*Polygonum pennsylvanicum*), lance-leaf frog-fruit, creeping spotflower, Virginian button-weed, white clover (*Trifolium repens*), rough cockle-bur, and chain-leaf aster. The hydrophytic vegetation criterion is met within this sample plot.

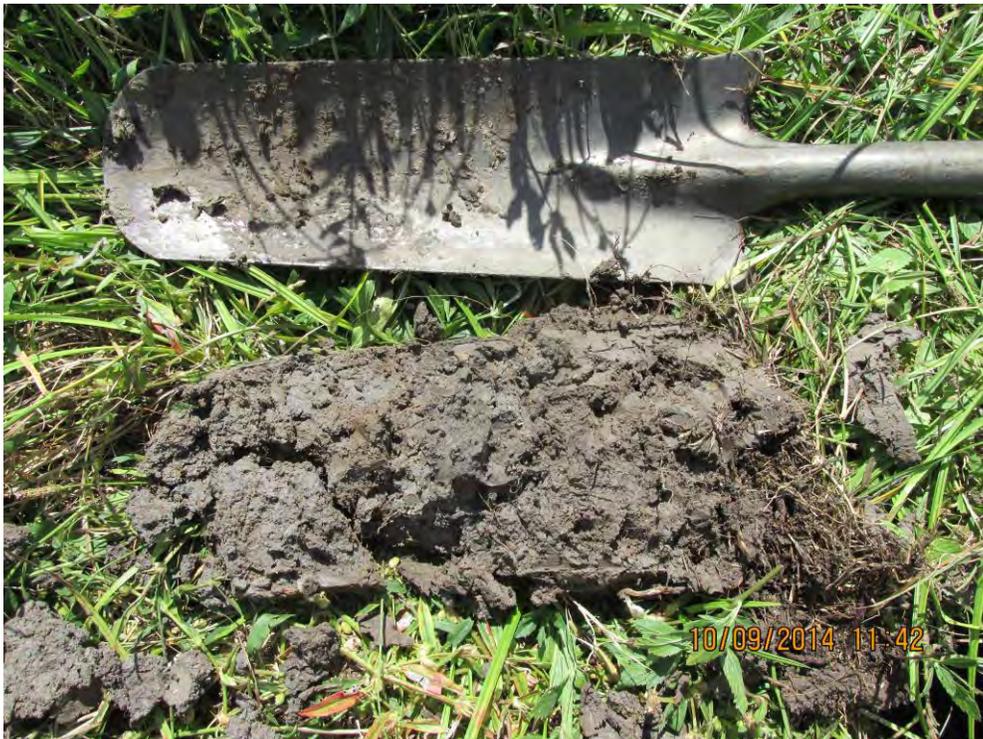
Photograph 20. Soil Profile Observed at Plot 8

The soils within this plot are mapped as Commerce silty clay loam. This series is listed on the National and the Louisiana Hydric Soils lists. Field observations concluded that the hydric soils criterion is met within this plot based on the presence of hydric soil indicators for a depleted matrix. Oxidized rhizospheres on living roots, is the only primary wetland hydrology indicator that was observed and recorded at the sample site. The only secondary indicator recorded was a positive FAC-Neutral test. The wetland hydrology criterion is met at this plot. It is GEC's opinion that this sample plot is within a wetland, based on the presence of hydrophytic vegetation, hydric soils, and wetland hydrology within the plot (see Data Form Plot - 8).

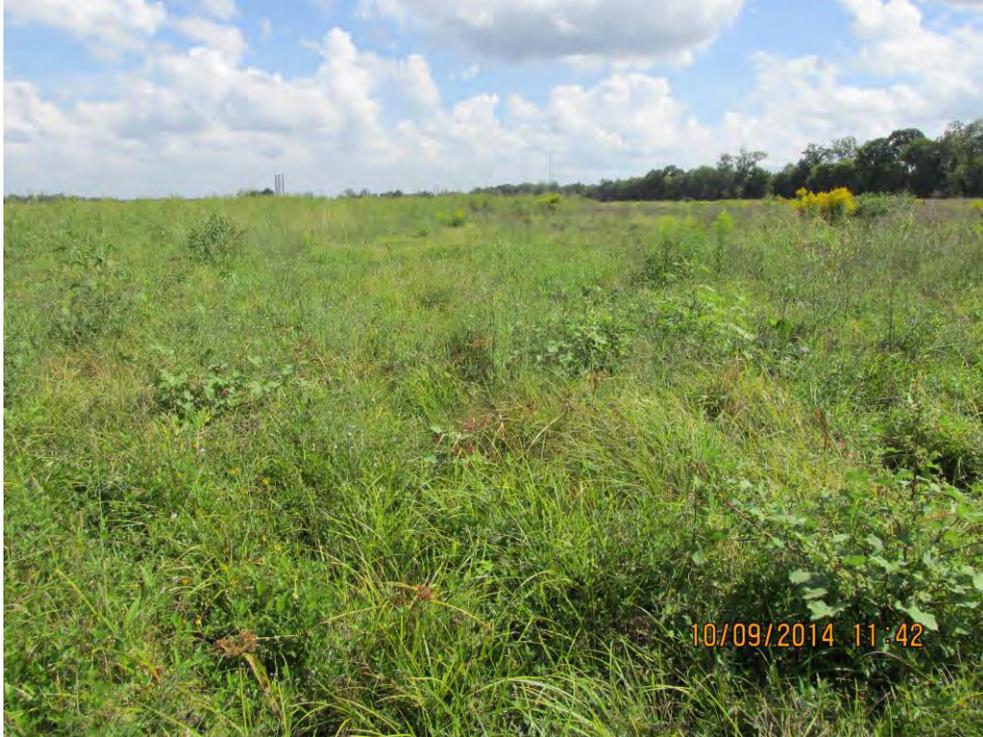
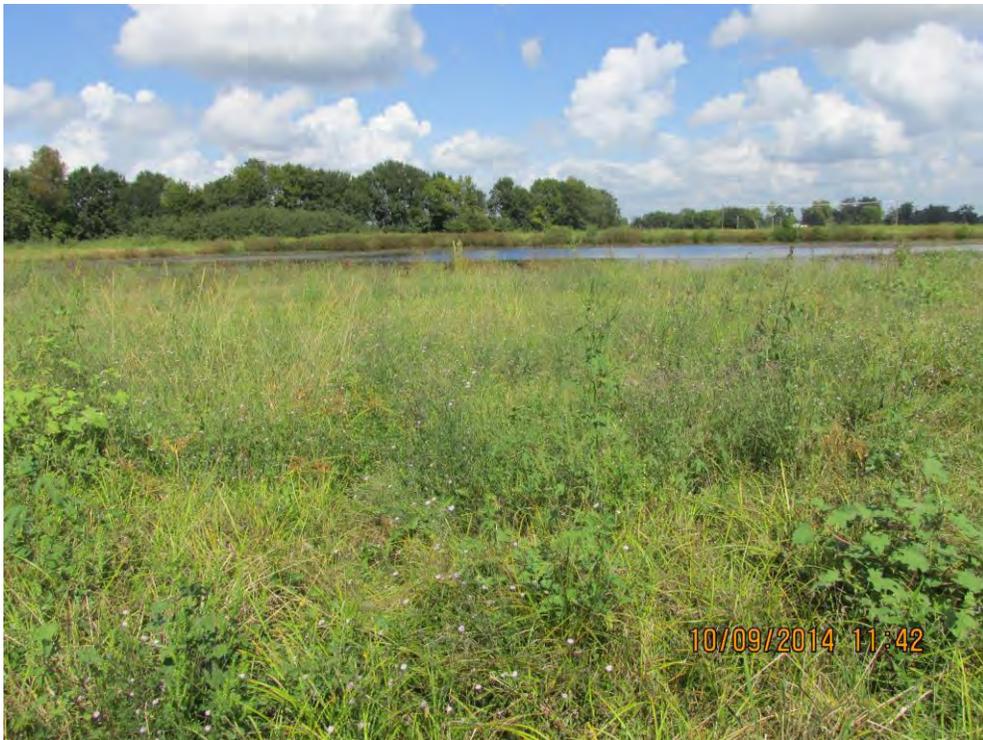
**Photograph 21. Overview of the Habitat Observed at Plot 8,
Facing East**

**Photograph 22. Overview of the Habitat Observed at Plot 8,
Facing North**

Sample Plot - 8: Sample Plot 8 is located in the southwestern portion of the property within a herbaceous habitat adjacent to a pond (Figure 3). This herbaceous habitat is dominated by

lance-leaf frog-fruit, green flatsedge, and blunt broom sedge. Additional species recorded but less abundant include creeping spotflower, chain-leaf aster, Virginia button-weed, Iria flatsedge (*Cyperus iria*), annual sumpweed, Florida Paspalum (*Paspalum floridanum*), Brazilian vervain (*Verbena brasiliensis*), and rough cockle-bur. The hydrophytic vegetation criterion is met within this sample plot.

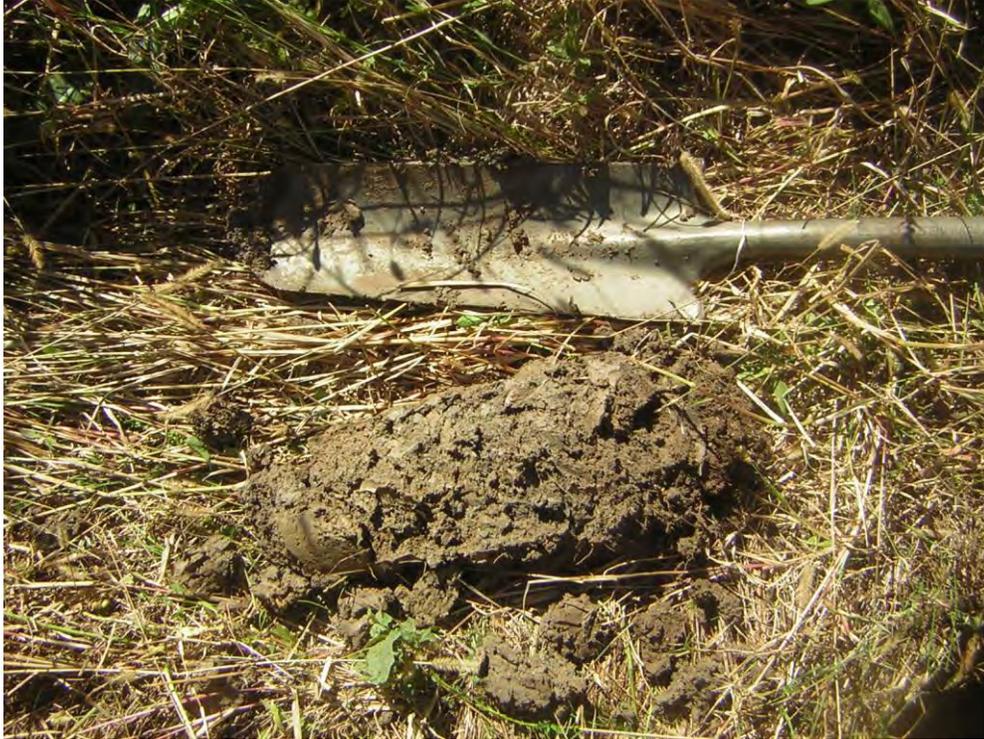
Photograph 23. Soil Profile Observed at Plot 9

The soils within this plot are mapped as Commerce silty clay loam. This series is listed on the National and the Louisiana Hydric Soils lists. Field observations concluded that the hydric soils criterion is met within this plot based on the presence of hydric soil indicators for a depleted matrix. There were no primary or secondary wetland hydrology indicators recorded within this sample plot. Therefore, the wetland hydrology criterion is not met at this sample plot. It is GEC's opinion that this sample plot is not within a wetland, based on the lack of hydrophytic vegetation and wetland hydrology within the plot (see Data Form Plot - 9).

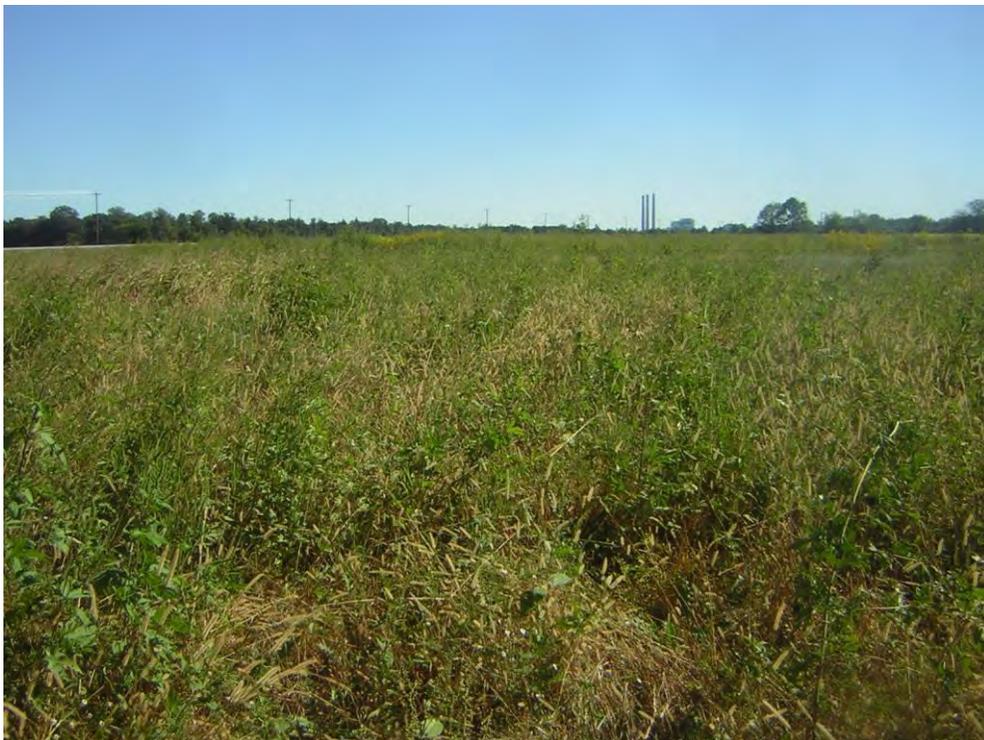
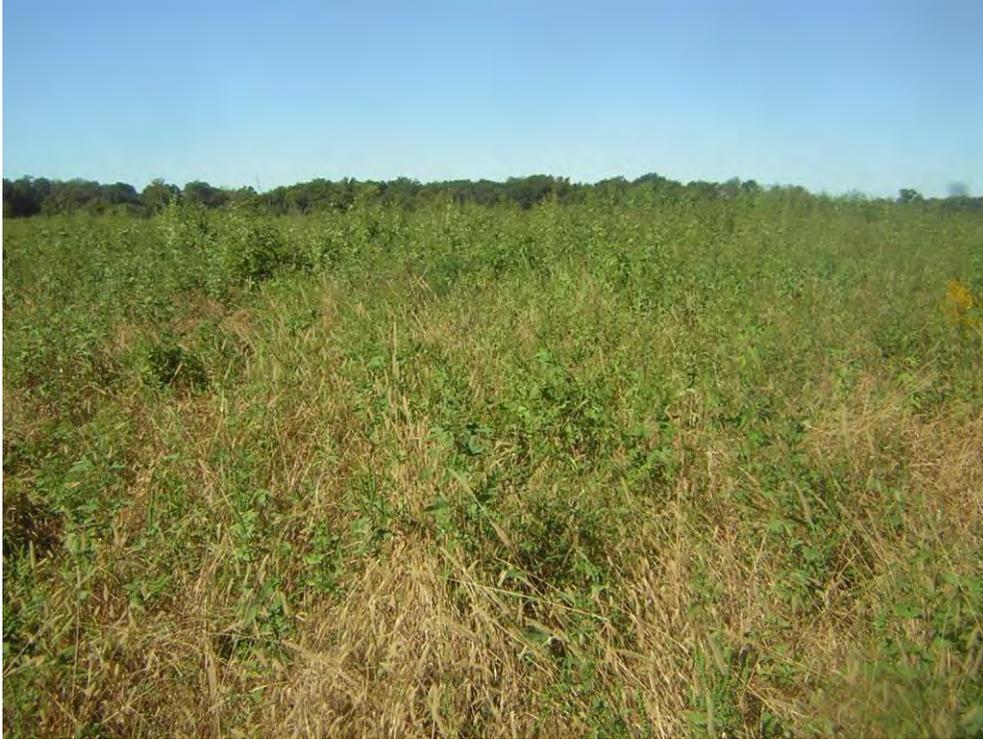
Photograph 24. Overview of the Habitat Observed at Plot 9, Facing East

**Photograph 25. Overview of the Habitat Observed at Plot 9,
Facing West**

Sample Plot - 9: Sample Plot 9 is located in the southern portion of the property south of LA Highway 10 within a fallow field. Dominant vegetation within this field is yellow foxtail (*Setaria pumila*) and Bermuda grass. Less dominant vegetation observed within the sample plot includes great ragweed (*Ambrosia trifida*), blunt broom sedge, Virginia button-weed, Canada golden-rod (*Solidago canadensis*), chain-leaf aster, yellow thistle (*Cirsium horridulum*), Carolina nightshade, Brazilian vervain, and annual sumpweed. The hydrophytic vegetation criterion is not met within this sample plot.

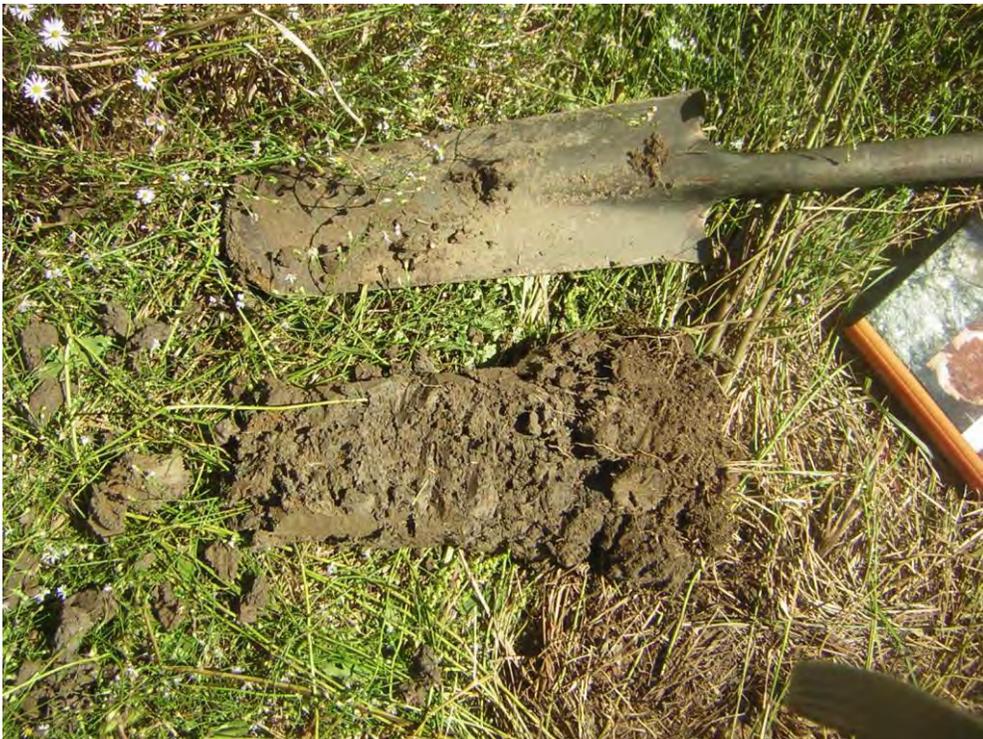
Photograph 26. Soil Profile Observed at Plot 10

The soils within this plot are mapped as Commerce silty clay loam. This series is listed on the National and the Louisiana Hydric Soils lists. Field observations concluded that the hydric soils criterion is met within this plot based on the presence of hydric soil indicators for a depleted matrix. Primary wetland hydrology indicators are lacking from this sample plot and only one secondary indicator, a positive FAC-Neutral test (D5) was documented. Therefore, the wetland hydrology criteria is not met within this sample plot. It is GEC's opinion that this sample plot is not within a wetland, based on the lack of wetland hydrology within the plot (see Data Form Plot - 10).

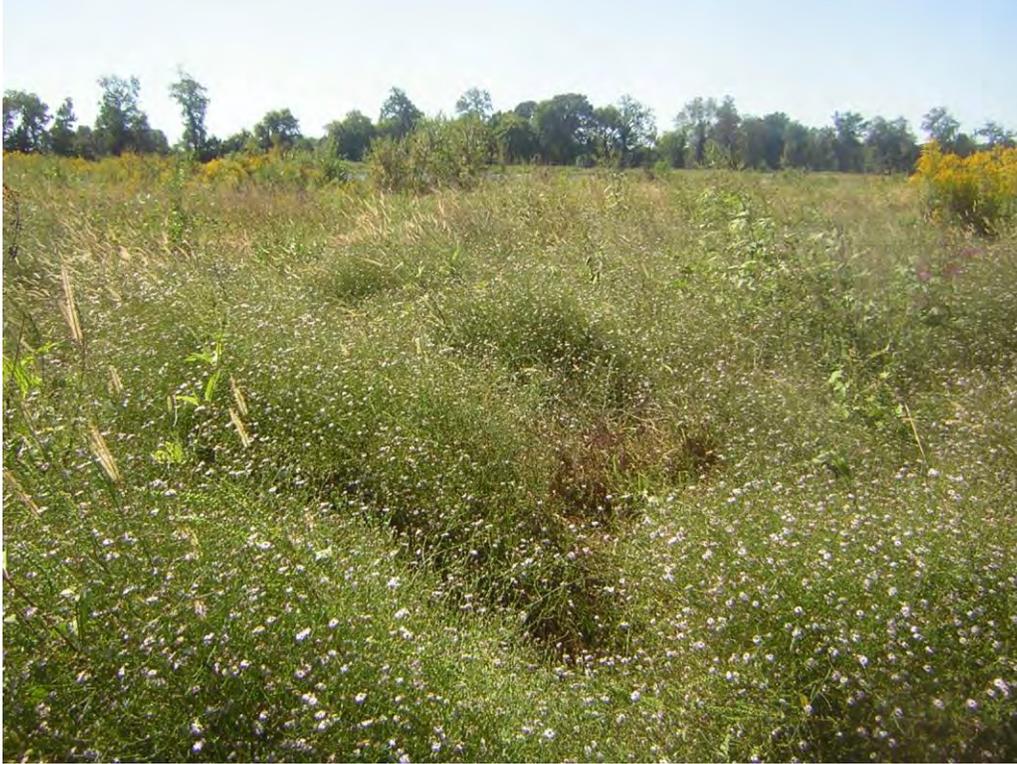
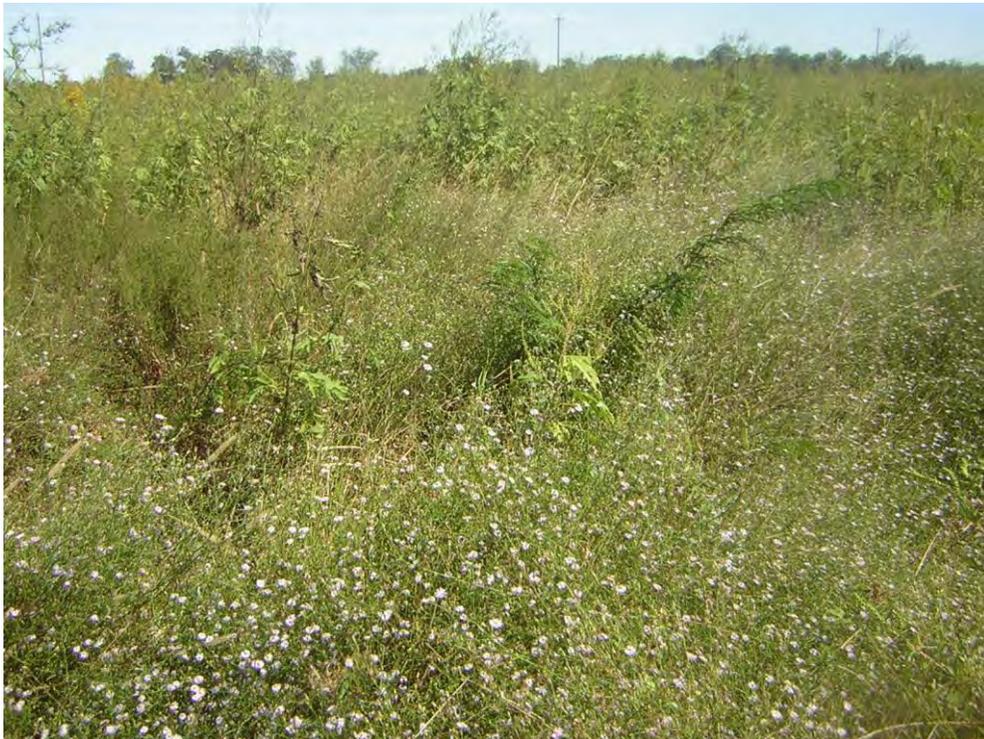
**Photograph 27. Overview of the Habitat Observed at Plot 10,
Facing South**

**Photograph 28. Overview of the Habitat Observed at Plot 10,
Facing North**

Sample Plot - 10: Sample Plot 10 is located in the southern portion of the property just south of LA Highway 10 within a fallow field. The dominant vegetation within this sample plot consists of chain-leaf aster and Virginia button-weed. Scattered occurrences of great ragweed, yellow foxtail, and Canada golden-rod were also recorded within this sample plot. The hydrophytic vegetation criterion is met within this sample plot.

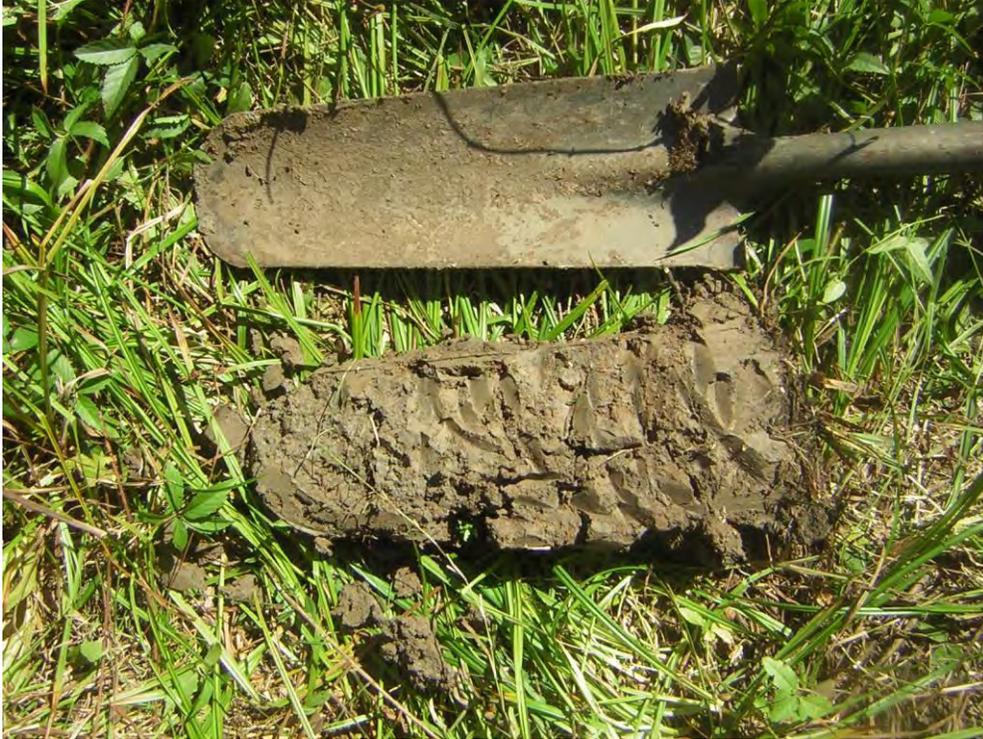
Photograph 29. Soil Profile Observed at Plot 11

The soils within this plot are mapped as Mhoon silty clay loam. This series is listed on the National and the Louisiana Hydric Soils lists. Field observations concluded that the hydric soils criterion is met within this plot based on the presence of hydric soil indicators for a depleted matrix. Primary wetland hydrology indicators recorded within this sample plot include water-stained leaves (B9) and oxidized rhizospheres on living roots (C3). Additionally, drainage patterns (B10), crayfish burrows (C8), and a positive FAC-Neutral test (D5) were also recorded within the sample plot as secondary hydrology indicators. Therefore, the wetland hydrology criteria is met within this sample plot. It is GEC's opinion that this sample plot is within a wetland, based on the presence of hydrophytic vegetation, hydric soils, and wetland hydrology within the plot (see Data Form Plot - 11).

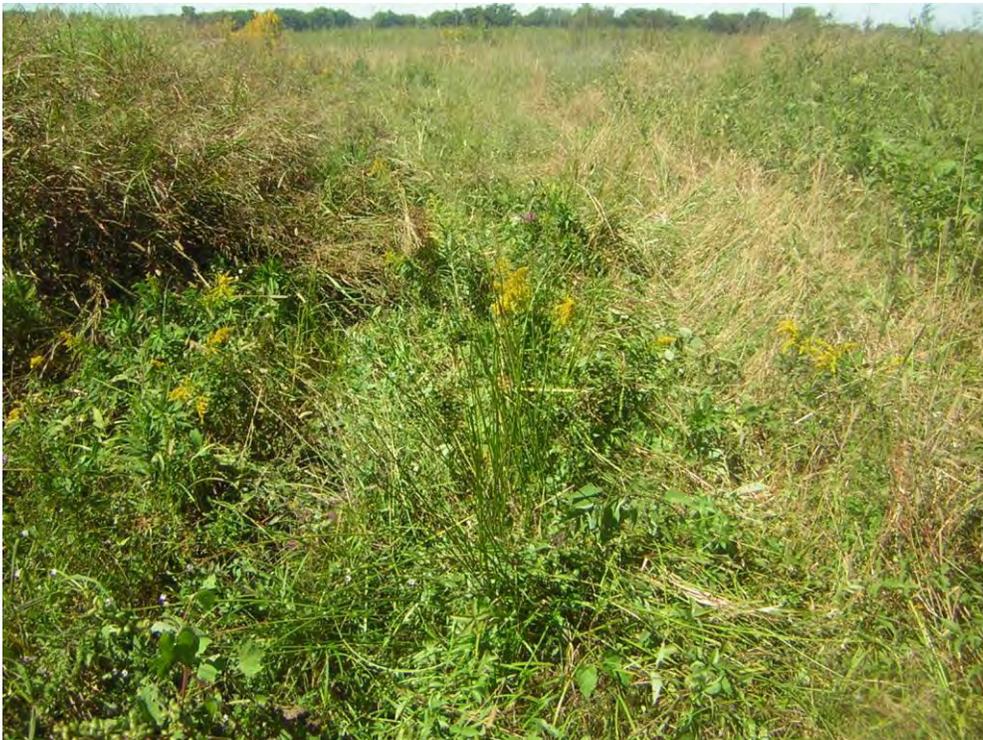
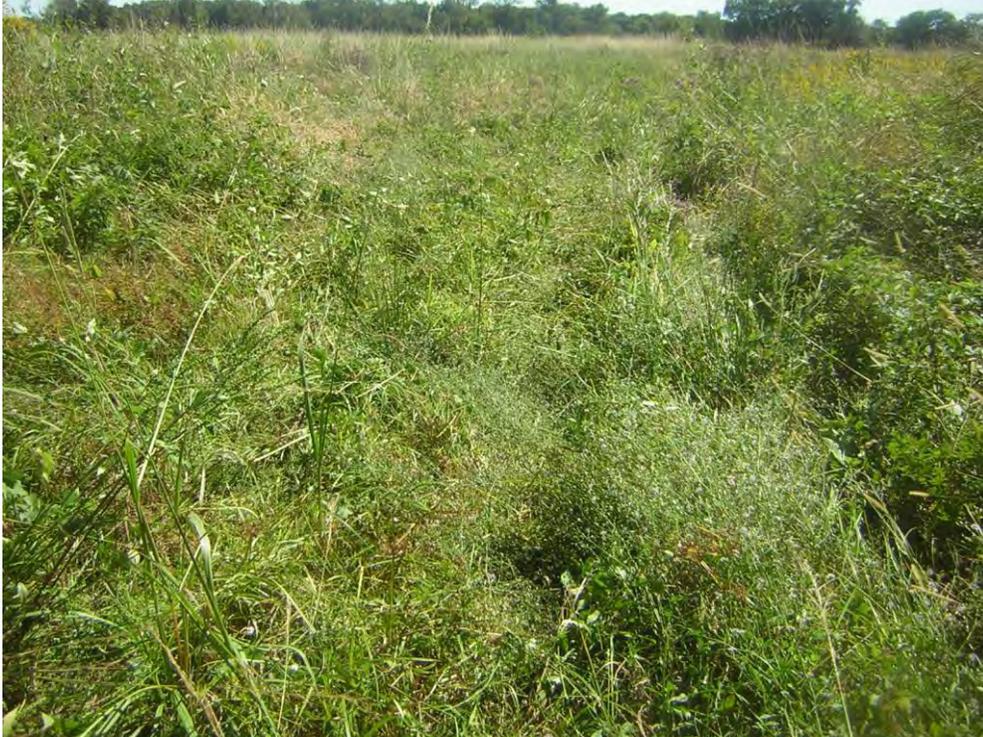
**Photograph 30. Overview of the Habitat Observed at Plot 11,
Facing Northwest**

Photograph 31. Overview of the Habitat Observed at Plot 11, Facing Southeast

Sample Plot - 11: Sample Plot 11 is located in the southern portion of the property just south of LA Highway 10 within a shallow drainage swale traversing through the fallow field. These drainage swales are dominated by green flatsedge, creeping spotflower, and winged loosestrife (*Lythrum alatum*). Other less abundant species include soft rush, marshpepper smartweed, annual sumpweed, vasey grass (*Paspalum urvillei*), lance-leaf frog-fruit, and Canada golden-rod. The hydrophytic vegetation criterion is met within this sample plot.

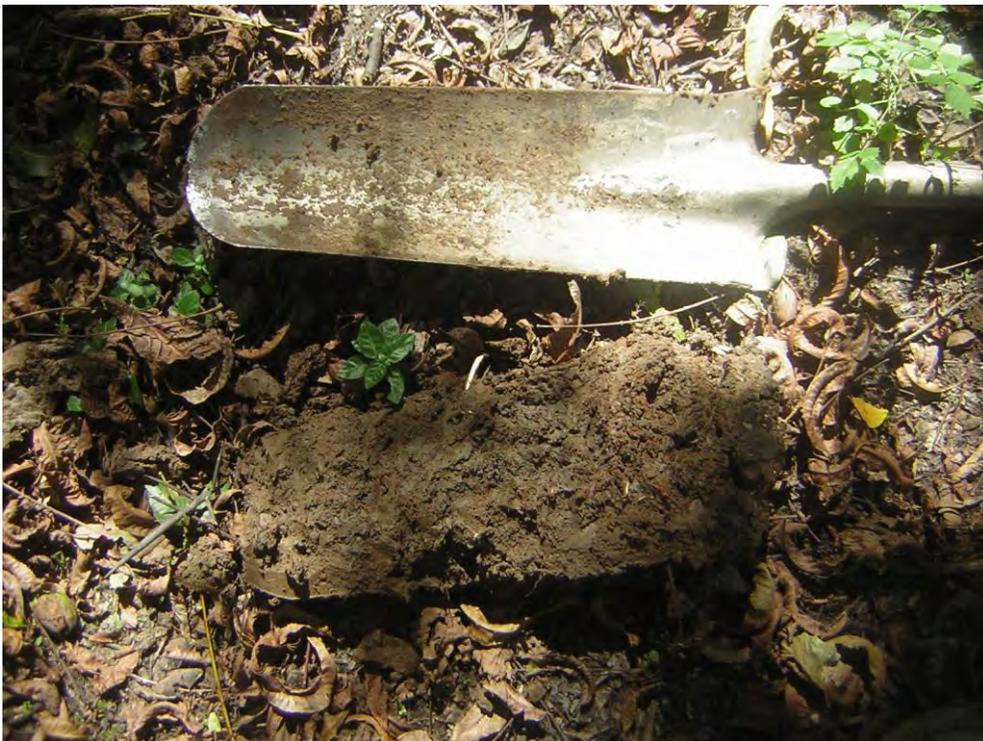
Photograph 32. Soil Profile Observed at Plot 12

The soils within this plot are mapped as Robinsonville and Commerce series. Both of these series are listed on the National and the Louisiana Hydric Soils lists. Field observations concluded that the hydric soils criterion is met within this plot based on the presence of hydric soil indicators for a depleted matrix. Primary wetland hydrology indicators recorded within this sample plot include water marks (B1), drift deposits (B3), and water-stained leaves (B9). The secondary indicators recorded for this sample plot include drainage patterns (B10), geomorphic position (D2), and a positive FAC-Neutral test (D5). Therefore, the wetland hydrology criteria is met within this sample plot. It is GEC's opinion that this sample plot is within a wetland, based on the presence of hydrophytic vegetation, hydric soils, and wetland hydrology within the plot (see Data Form Plot - 12).

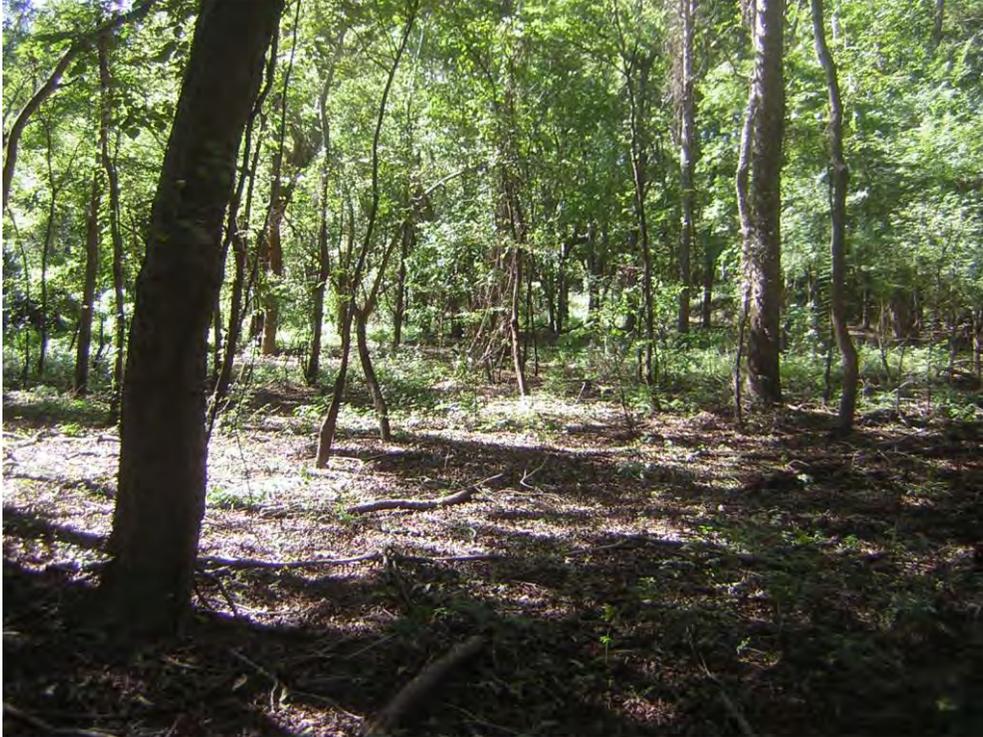
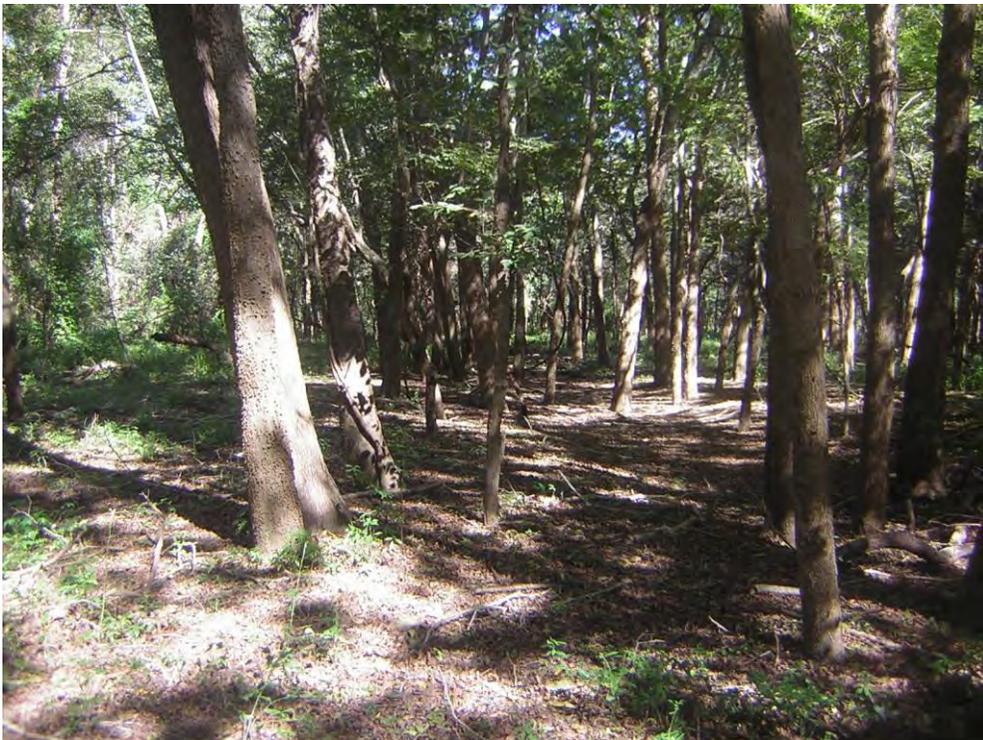
**Photograph 33. Overview of the Habitat Observed at Plot 12,
Facing South**

**Photograph 34. Overview of the Habitat Observed at Plot 12,
Facing East**

Sample Plot - 12: Sample Plot 12 is located in the northwestern portion of the property on the river side of the protection levee within the forested batture (Figure 3). The dominant trees within this sample plot include pecan hickory and sugarberry. Other trees occurring but less abundant include common persimmon (*Diospyros virginiana*) and water-locust (*Gleditsia aquatica*). The shrub stratum was dominated by common buttonbush (*Cephalanthus occidentalis*) and swamp privet (*Forestiera acuminata*). Dominant herbaceous vegetation includes small-spike false-nettle (*Boehmeria cylindrical*), redvine (*Brunnichia cirrhosa*), and white heath aster (*Aster pilosus*). The dominant woody vine species include river-bank grape (*Vitis riparia*), trumpet creeper (*Campsis radicans*), and poison ivy (*Toxicodendron radicans*). Saw greenbrier (*Smilax bona-nox*) was also present but was not a dominant. The hydrophytic vegetation criterion is met within this sample plot.

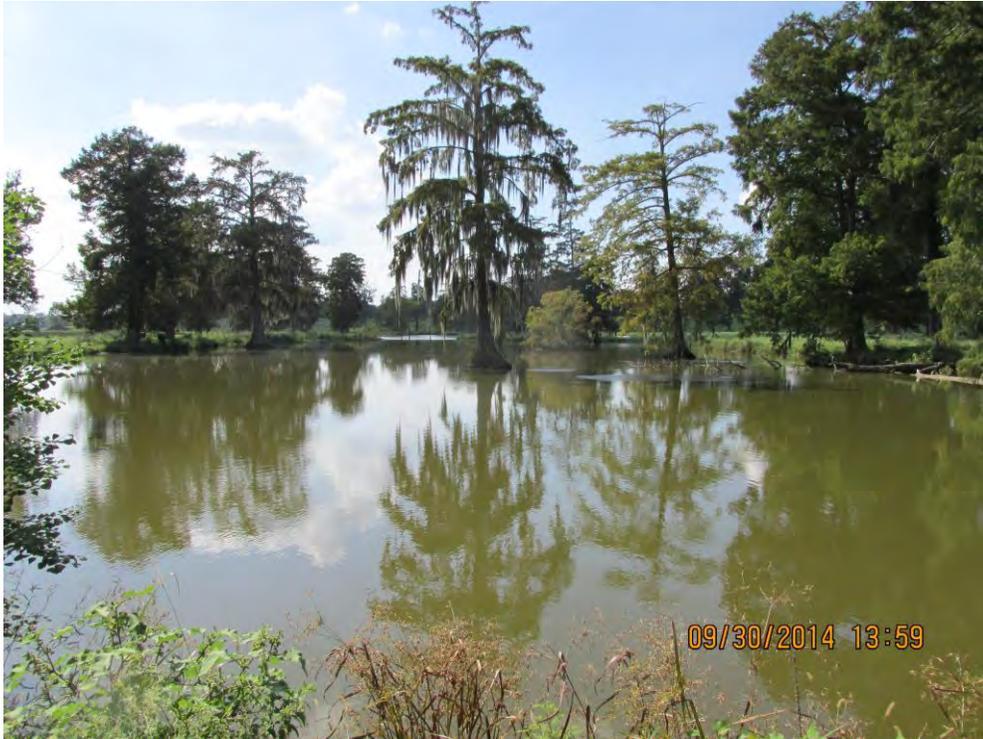
Photograph 35. Large Pond at Northeast Portion of Property Just South of LA Highway 981

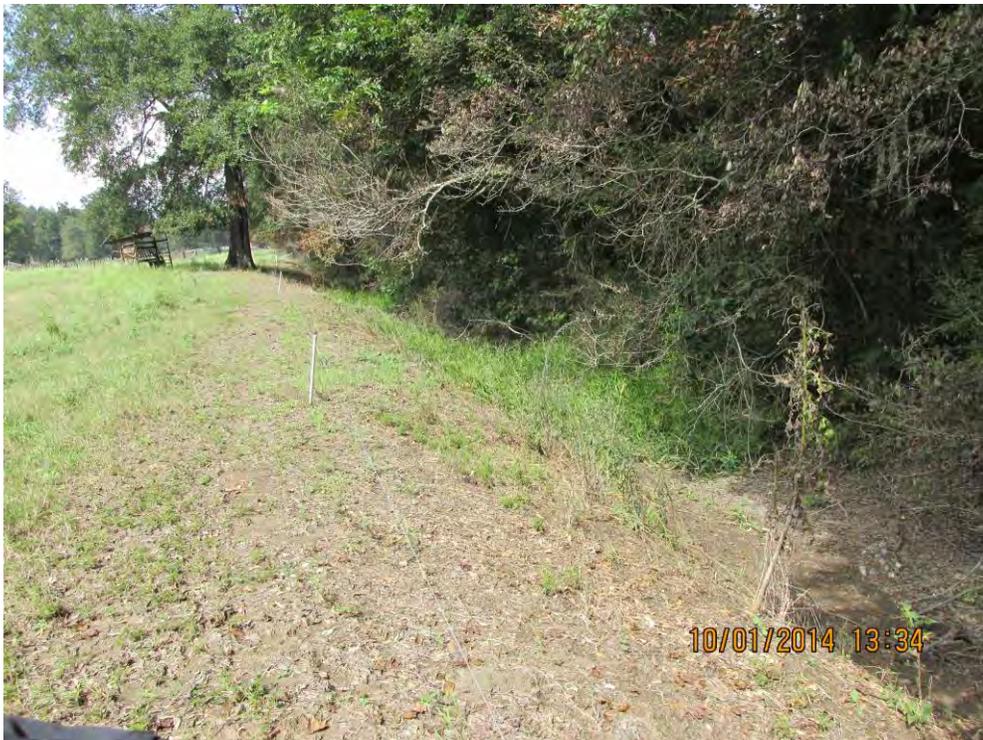
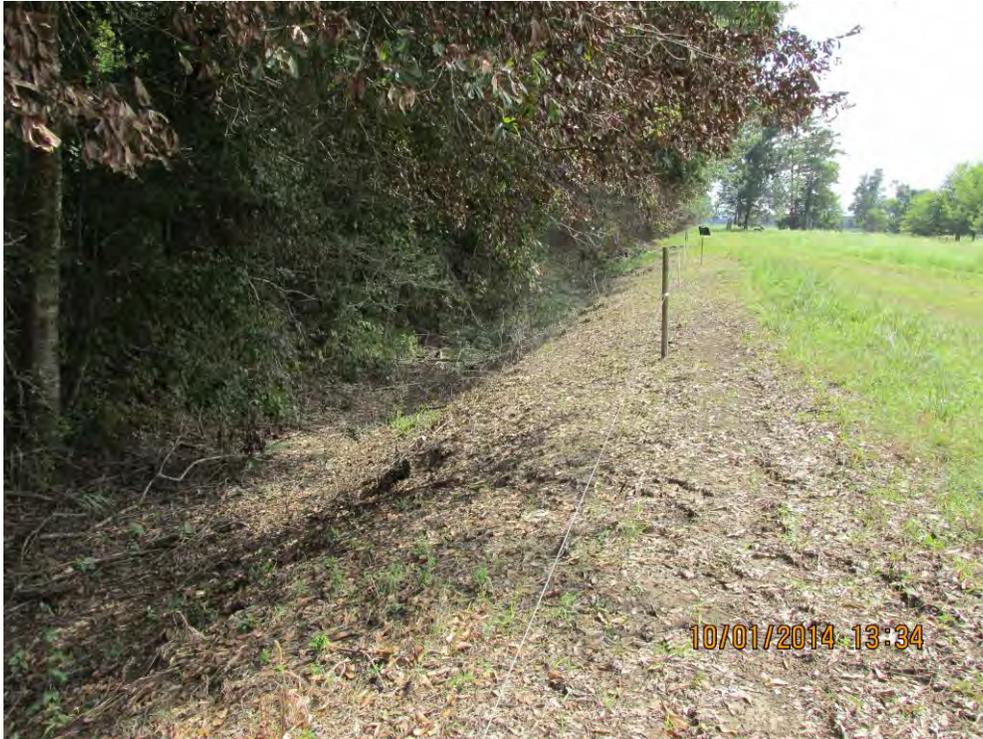
Photograph 36. Drainage Canal Along the East Side of the Property, Facing North

Photograph 37. Drainage Canal Along the East Side of the Property, Facing South

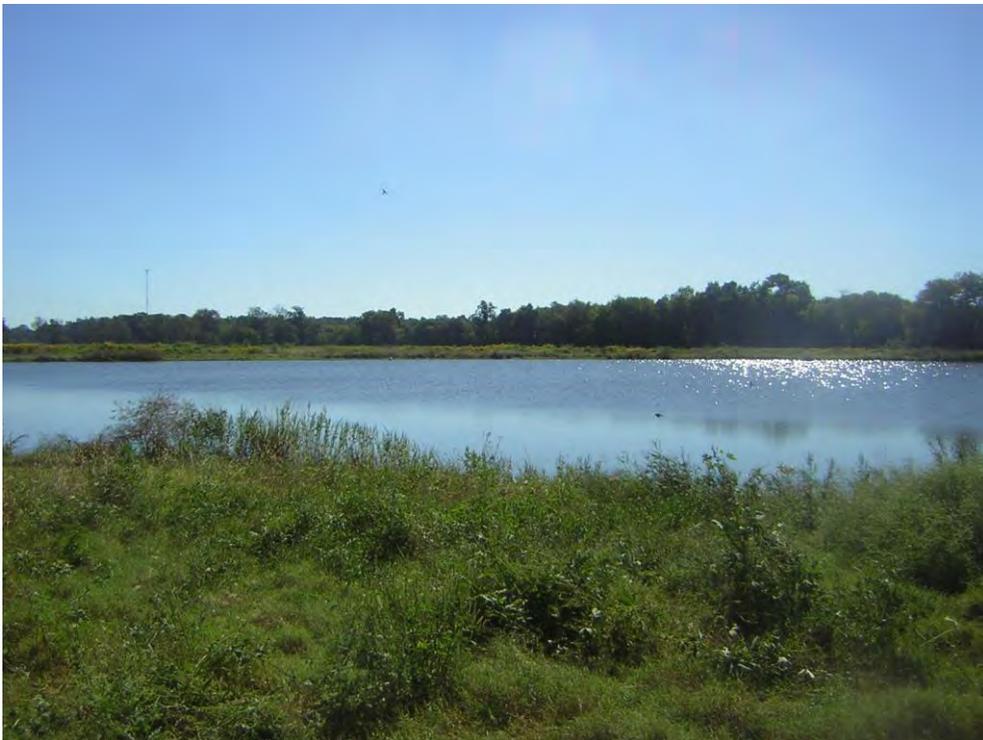
Photograph 38. Large Pond South of LA Highway 10, Facing Southeast

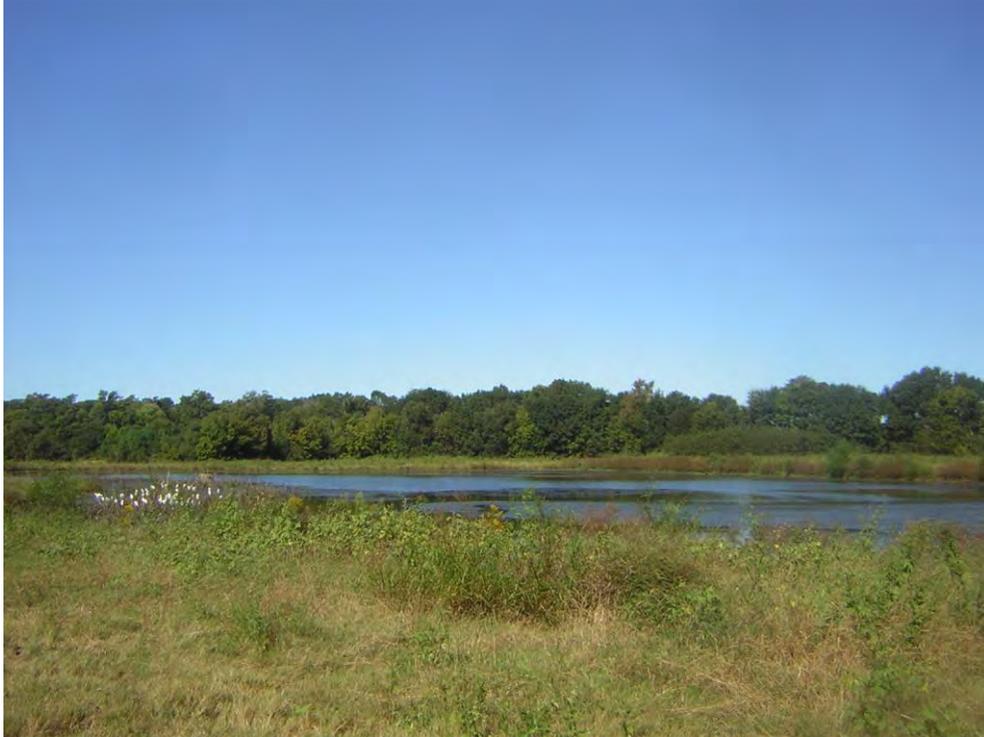
**Photograph 39. Smaller Pond South of LA Highway 10,
Facing West**

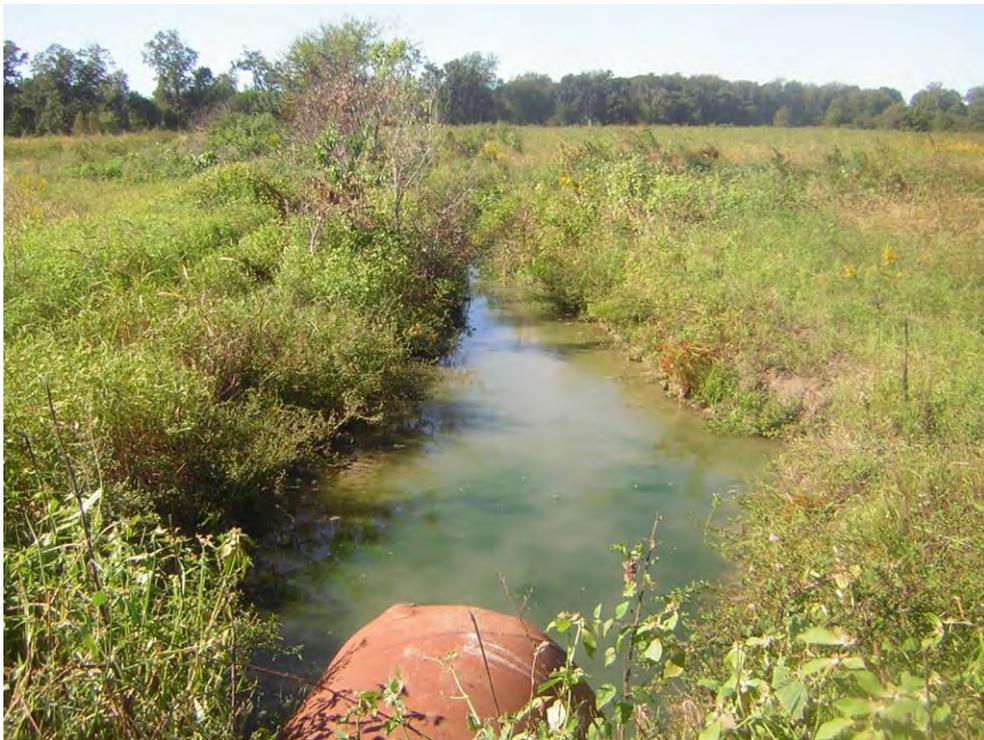
**Photograph 40. Wetland Drain Traversing Through the Center of the
Property South of LA Highway 10, Facing East**

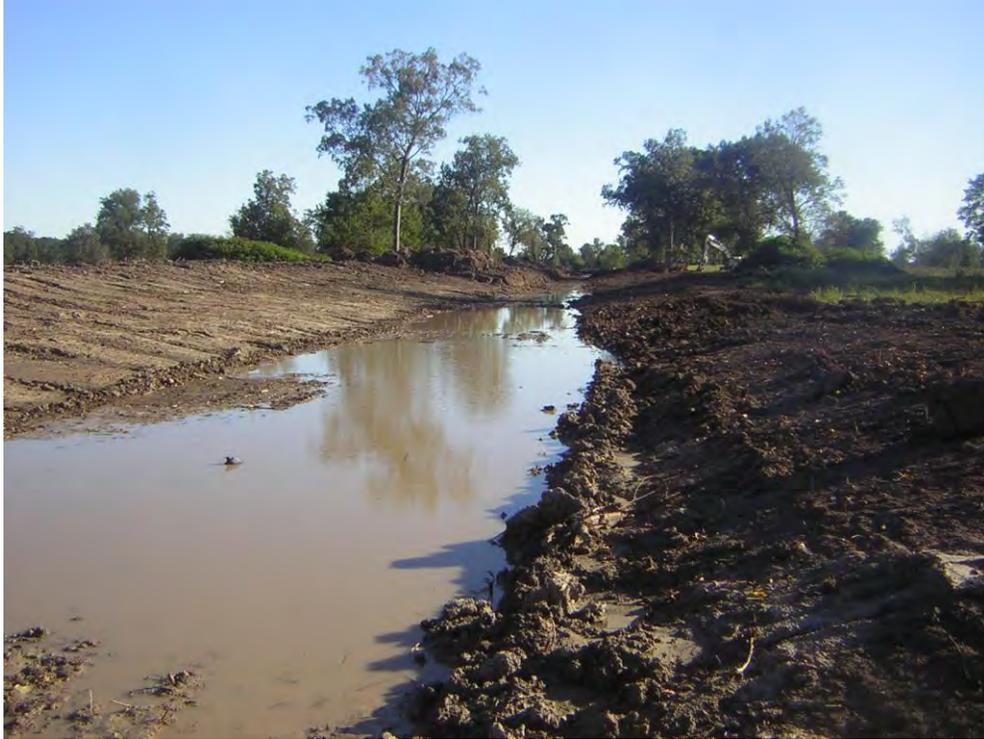
Photograph 41. Excavated Drainage Canal Traversing the Center of the Property, Facing South
